8 Main Street,
Lybster,
KW3 6AE

Home Report

Survey Report on:

3rd November 2025

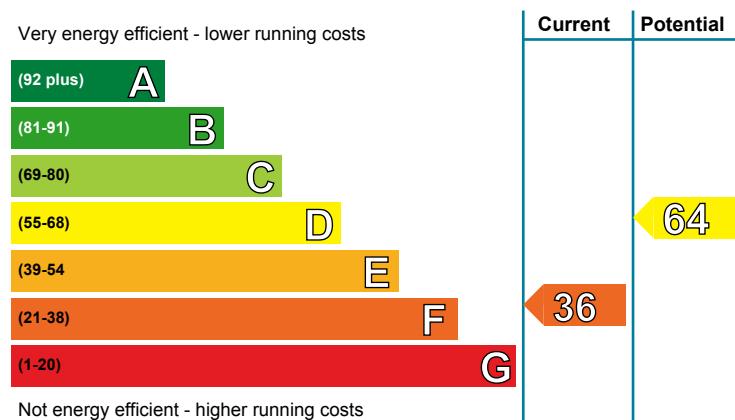
Energy Efficiency Rating

Your current rating is **band F (36)**. The average rating for EPCs in Scotland is **band D (61)**.

Recommended measures	Indicative cost	Typical savings over 3 years
1 Internal wall insulation	£7,500 - £11,000	£1446.00
2 Floor insulation (solid floor)	£5,000 - £10,000	£219.00
3 Increase hot water cylinder insulation	£20 - £40	£333.00
