10,
Asquith Street,
Kirkcaldy,
Fife,
KY1 1PW

Home Report

Single Survey

1397848

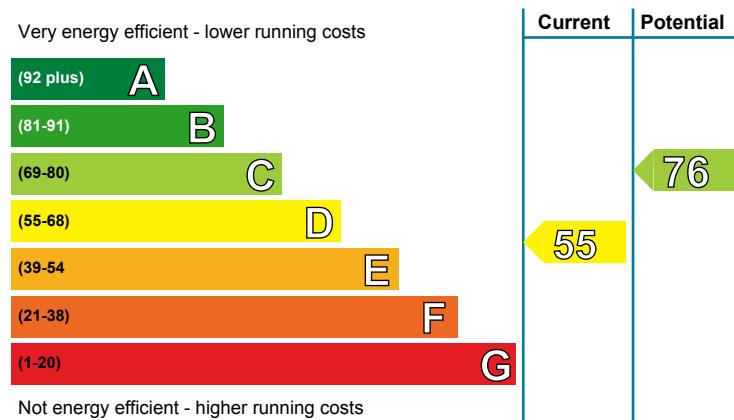
Energy Efficiency Rating

This graph shows the current efficiency of your home, taking into account both energy efficiency and fuel costs. The higher this rating, the lower your fuel bills are likely to be.

Your current rating is **band D (55)**. The average rating for EPCs in Scotland is **band D (61)**.

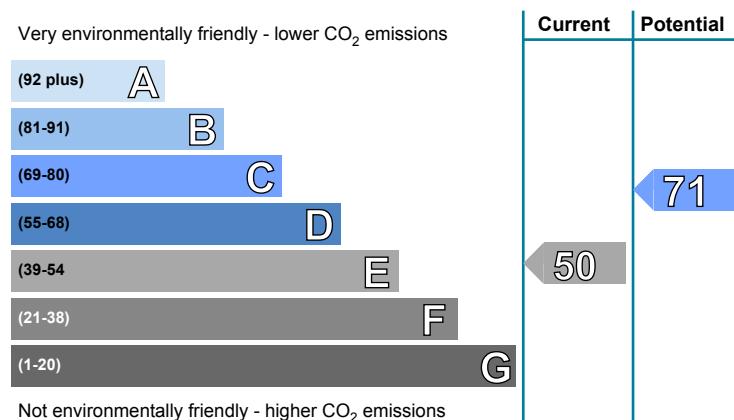
Environmental Impact (CO₂) Rating

This graph shows the effect of your home on the environment in terms of carbon dioxide (CO₂) emissions. The higher the rating, the less impact it has on the environment.
