34 Heathfield Road,
Ormlie,
Thurso,
KW14 7DT

Home Report

Single Survey

Property Address	34 Heathfield Road, Ormlie, Thurso, KW14 7DT
Reference	977456
Customer Name	Michael and Lorna Miller
Date of Inspection	19th March 2025
Surveyor's name, qualifications and office	Lesley Coghill BSc (Hons) MRICS
Prepared By	DM Hall LLP

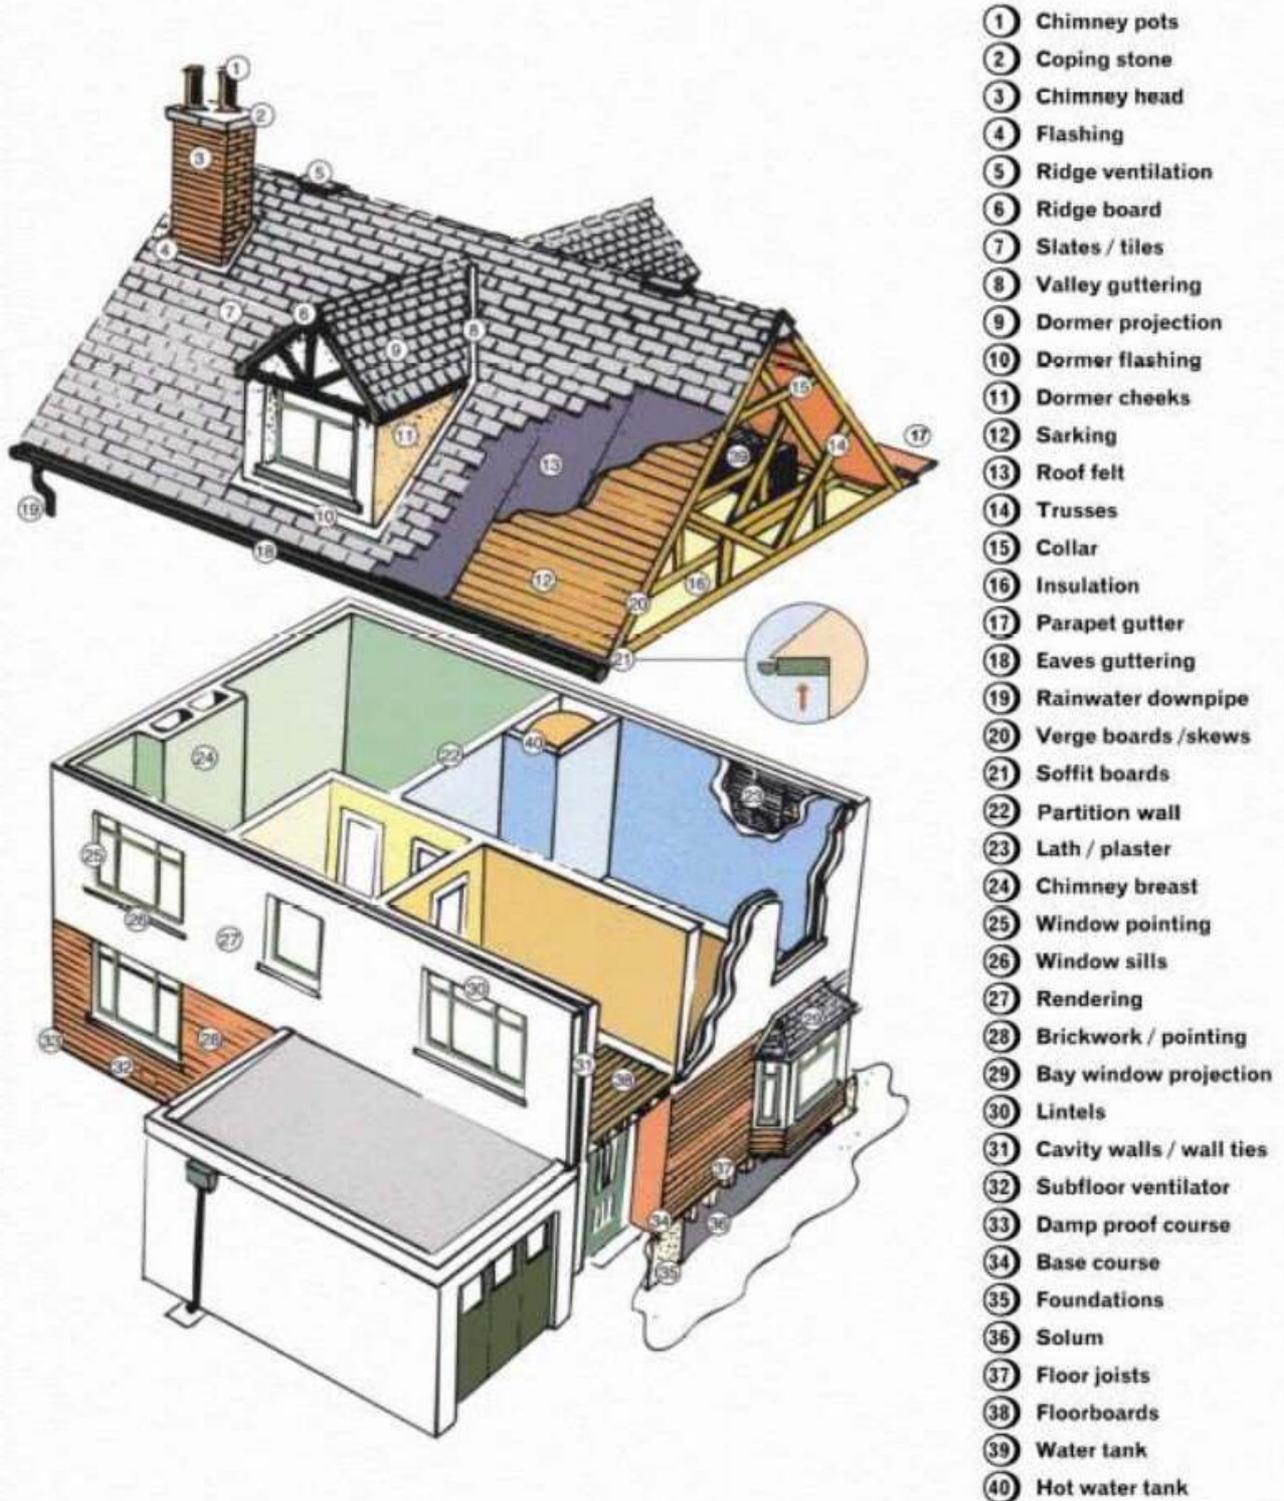
Sectional Diagram showing elements of a typical house

Reference may be made in this report to some or all of the above component parts of the property. This diagram may assist you in locating and understanding these items.

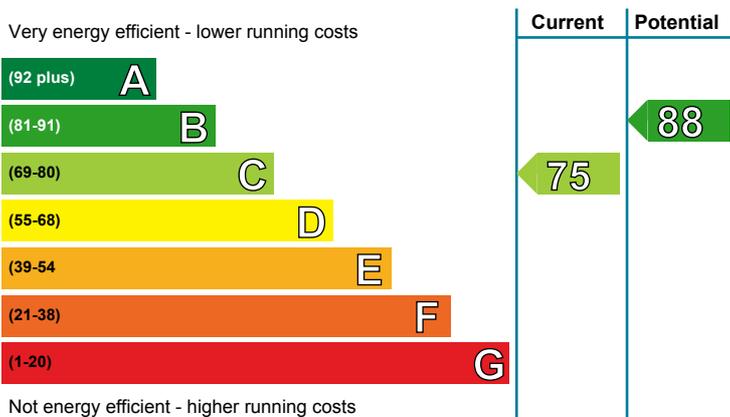
Energy Efficiency Rating

This graph shows the current efficiency of your home, taking into account both energy efficiency and fuel costs. The higher this rating, the lower your fuel bills are likely to be.

Your current rating is **band C (75)**. The average rating for EPCs in Scotland is **band D (61)**.

The potential rating shows the effect of undertaking all of the improvement measures listed within your recommendations report.

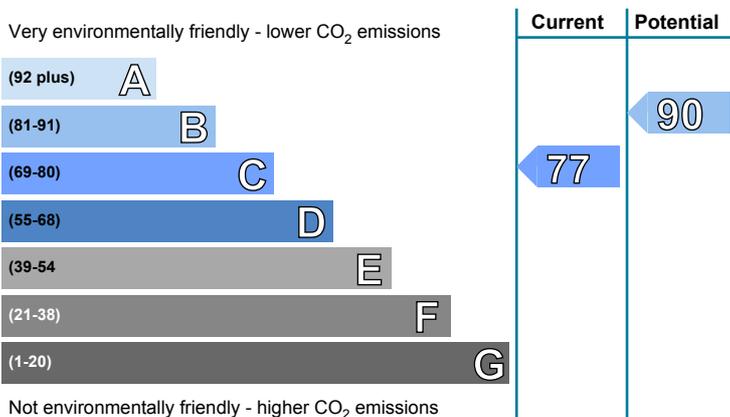
Environmental Impact (CO₂) Rating

This graph shows the effect of your home on the environment in terms of carbon dioxide (CO₂) emissions. The higher the rating, the less impact it has on the environment.
