Bayview Cottage,
Portskerra,
Melvich,
Thurso,
Caithness,
KW14 7YL

Home Report

Single Survey

SINGLE SURVEY TERMS AND CONDITIONS (WITH MVR)

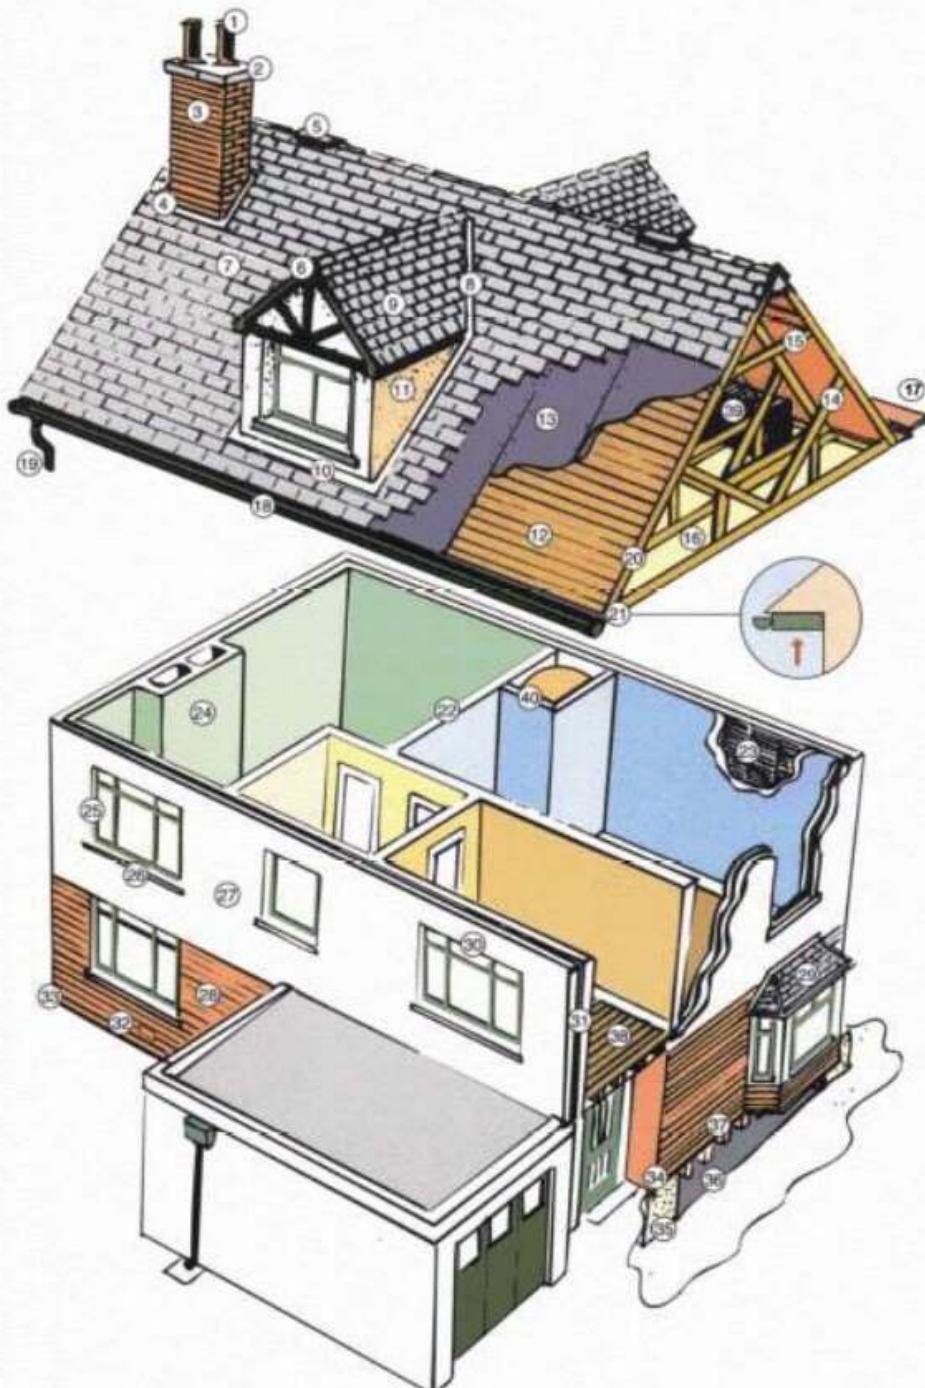
Sectional Diagram showing elements of a typical house

- 1 Chimney pots
- 2 Coping stone
- 3 Chimney head
- 4 Flashing
- 5 Ridge ventilation
- 6 Ridge board
- 7 Slates / tiles
- 8 Valley guttering
- 9 Dormer projection
- 10 Dormer flashing
- 11 Dormer cheeks
- 12 Sarking
- 13 Roof felt
- 14 Trusses
- 15 Collar
- 16 Insulation
- 17 Parapet gutter
- 18 Eaves guttering
- 19 Rainwater downpipe
- 20 Verge boards / skewers
- 21 Soffit boards
- 22 Partition wall
- 23 Lath / plaster
- 24 Chimney breast
- 25 Window pointing
- 26 Window sills
- 27 Rendering
- 28 Brickwork / pointing
- 29 Bay window projection
- 30 Lintels
- 31 Cavity walls / wall ties
- 32 Subfloor ventilator
- 33 Damp proof course
- 34 Base course
- 35 Foundations
- 36 Solum
- 37 Floor joists
- 38 Floorboards
- 39 Water tank
- 40 Hot water tank

Reference may be made in this report to some or all of the above component parts of the property. This diagram may assist you in locating and understanding these items.
