9 Castle Terrace,
Thurso,
Caithness,
KW14 8HS

Home Report

Single Survey

Property Address	9 Castle Terrace, Thurso, Caithness, KW14 8HS
Reference	1438413
Customer Name	Peter & Mrs Rachel O'Hare
Date of Inspection	18th February 2026
Surveyor's name, qualifications and office	Simone Coles DM Hall LLP Chartered Surveyors Hope House, Cradlehall Business Park, Castlehill Drive Cradlehall Inverness IV2 5GH Tel: 01463 241077 email: invernessresidential@dmhall.co.uk
Prepared By	DM Hall LLP

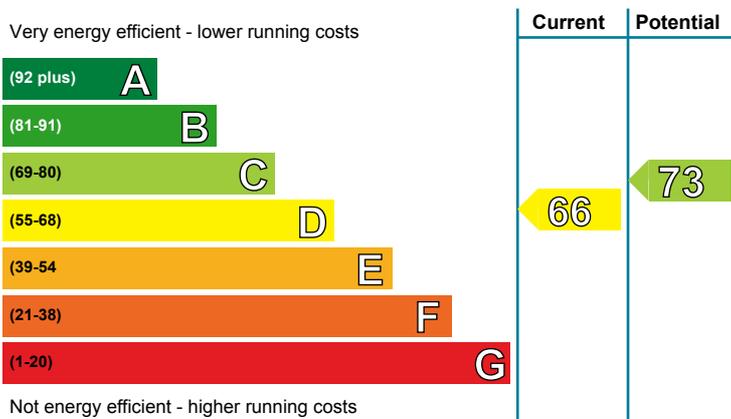
Energy Efficiency Rating

This graph shows the current efficiency of your home, taking into account both energy efficiency and fuel costs. The higher this rating, the lower your fuel bills are likely to be.

Your current rating is **band D (66)**. The average rating for EPCs in Scotland is **band D (61)**.

The potential rating shows the effect of undertaking all of the improvement measures listed within your recommendations report.

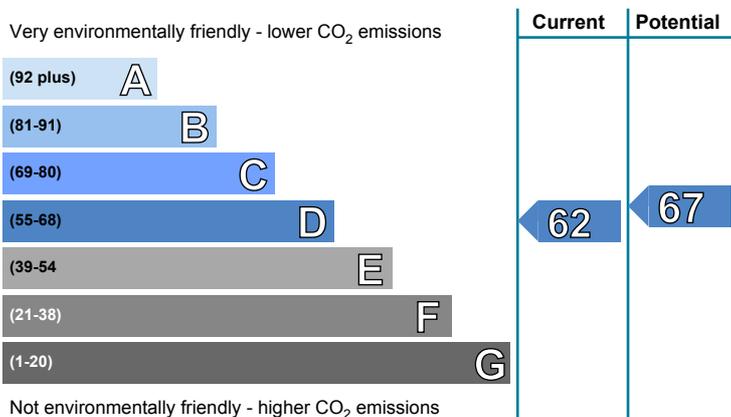
Environmental Impact (CO₂) Rating

This graph shows the effect of your home on the environment in terms of carbon dioxide (CO₂) emissions. The higher the rating, the less impact it has on the environment.
