3 Pollok Place,
Thurso,
KW14 7QL

Home Report

Single Survey

Property Address	3 Pollok Place, Thurso, KW14 7QL
Reference	1014870
Customer Name	Henry Shanks and Aileen Shanks
Date of Inspection	23rd April 2025
Surveyor's name, qualifications and office	Lesley Coghill BSc (Hons) MRICS DM Hall LLP Chartered Surveyors Hope House, Cradlehall Business Park, Castlehill Drive Cradlehall Inverness IV2 5GH Tel: 01463 241077 email: invernessresidential@dmhall.co.uk
Prepared By	DM Hall LLP

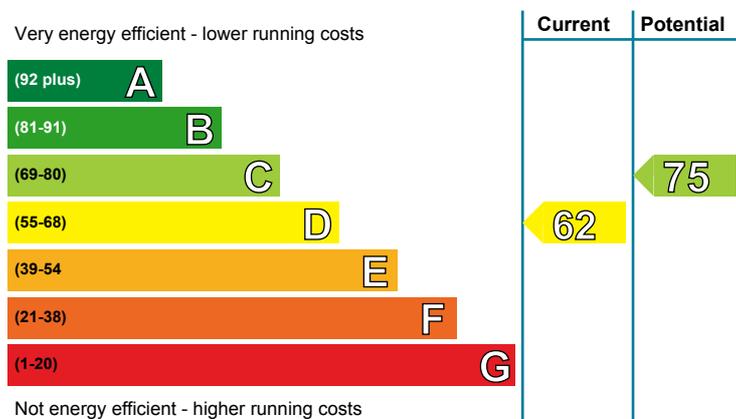
Energy Efficiency Rating

This graph shows the current efficiency of your home, taking into account both energy efficiency and fuel costs. The higher this rating, the lower your fuel bills are likely to be.

Your current rating is **band D (62)**. The average rating for EPCs in Scotland is **band D (61)**.

The potential rating shows the effect of undertaking all of the improvement measures listed within your recommendations report.

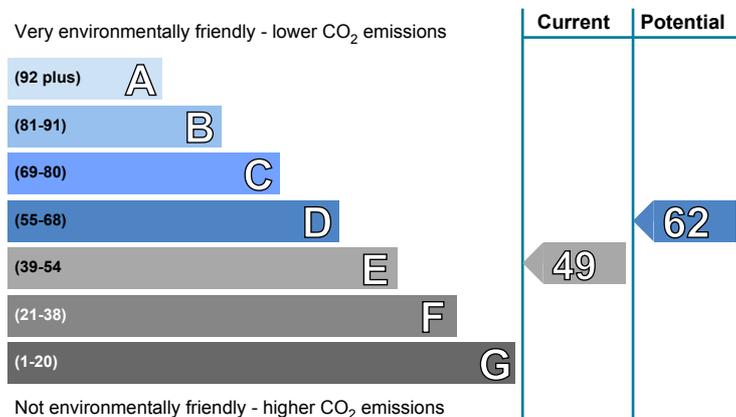
Environmental Impact (CO₂) Rating

This graph shows the effect of your home on the environment in terms of carbon dioxide (CO₂) emissions. The higher the rating, the less impact it has on the environment.
