Home Report

3 Baltimore Place,
Thurso,
KW14 7EX

Single Survey

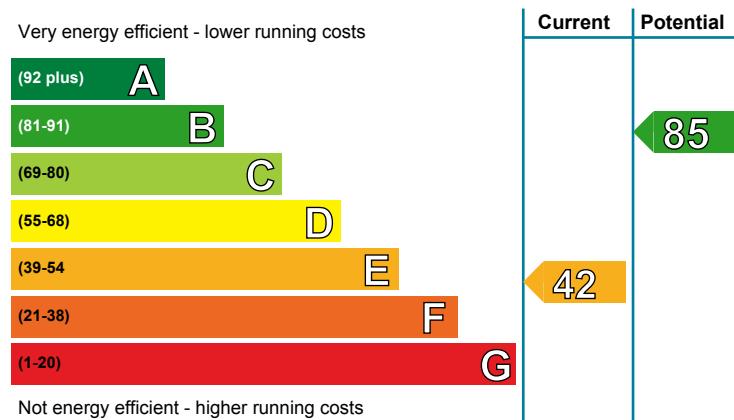
Energy Efficiency Rating

This graph shows the current efficiency of your home, taking into account both energy efficiency and fuel costs. The higher this rating, the lower your fuel bills are likely to be.

Your current rating is **band E (42)**. The average rating for EPCs in Scotland is **band D (61)**.

The potential rating shows the effect of undertaking all of the improvement measures listed within your recommendations report.

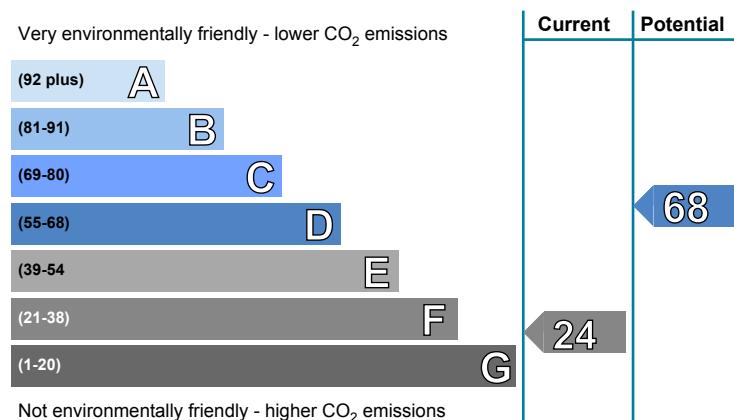
Environmental Impact (CO₂) Rating

This graph shows the effect of your home on the environment in terms of carbon dioxide (CO₂) emissions. The higher the rating, the less impact it has on the environment.
