# HOME REPORT

24 SPRINGPARK TERRACE  
SPRINGPARK  
THURSO  
KW14 8NN

# Energy Performance Certificate (EPC)

# Single Survey

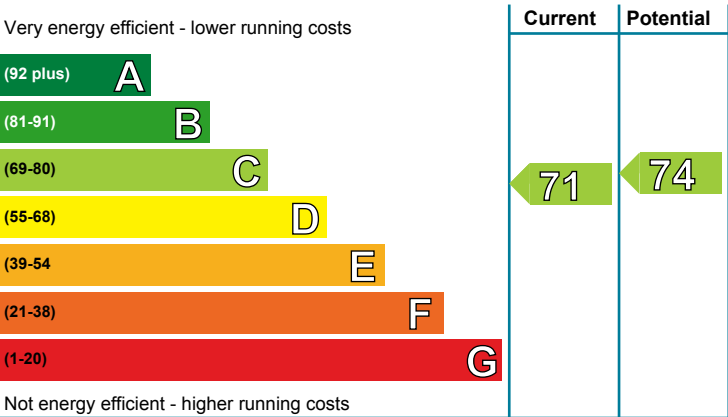
### Energy Efficiency Rating

This graph shows the current efficiency of your home, taking into account both energy efficiency and fuel costs. The higher this rating, the lower your fuel bills are likely to be.

Your current rating is **band C (71)**. The average rating for EPCs in Scotland is **band D (61)**.

The potential rating shows the effect of undertaking all of the improvement measures listed within your recommendations report.

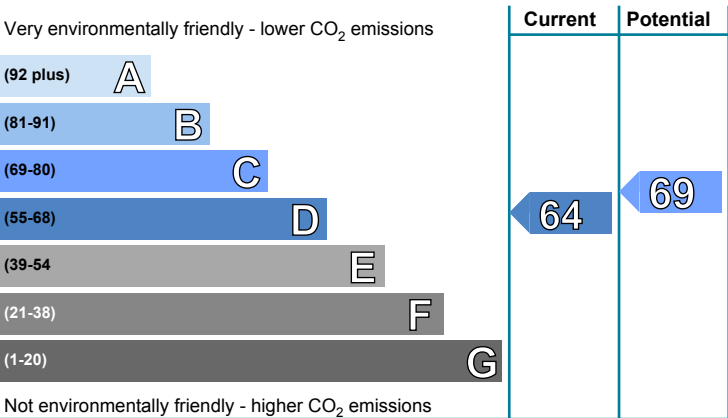
### Environmental Impact (CO<sub>2</sub>) Rating

This graph shows the effect of your home on the environment in terms of carbon dioxide (CO<sub>2</sub>) emissions. The higher the rating, the less impact it has on the environment.

Your current rating is **band D (64)**. The average rating for EPCs in Scotland is **band D (59)**.

The potential rating shows the effect of undertaking all of the improvement measures listed within your recommendations report.
