Home Report

THE CHIMNEYS CASTLETOWN

THURSO
KW14 8SX

Energy Performance Certificate

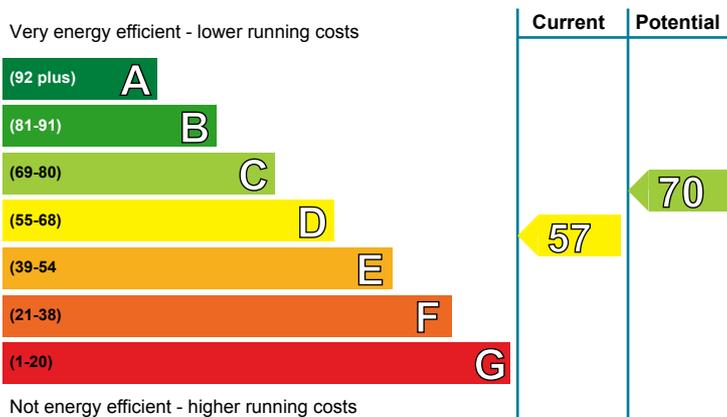
Energy Efficiency Rating

This graph shows the current efficiency of your home, taking into account both energy efficiency and fuel costs. The higher this rating, the lower your fuel bills are likely to be.

Your current rating is **band D (57)**. The average rating for EPCs in Scotland is **band D (61)**.

The potential rating shows the effect of undertaking all of the improvement measures listed within your recommendations report.

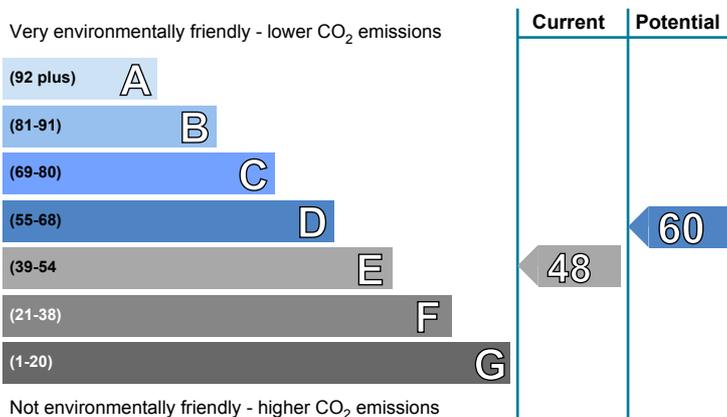
Environmental Impact (CO₂) Rating

This graph shows the effect of your home on the environment in terms of carbon dioxide (CO₂) emissions. The higher the rating, the less impact it has on the environment.

Your current rating is **band E (48)**

The potential rating shows the effect of undertaking all of the improvement measures listed within your recommendations report.
