# HOME REPORT

31 THORFINN TERRACE  
THURSO  
KW14 7LL

DM HALL  
CHARTERED SURVEYORS

31 THORFINN TERRACE, THURSO, KW14 7LL

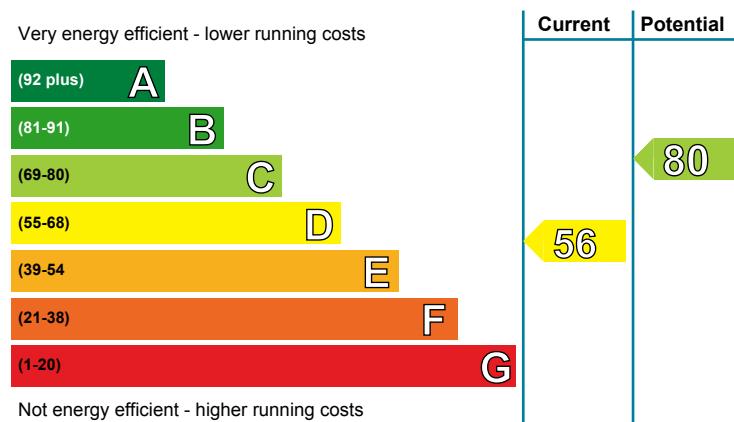
## Energy Efficiency Rating

This graph shows the current efficiency of your home, taking into account both energy efficiency and fuel costs. The higher this rating, the lower your fuel bills are likely to be.

Your current rating is **band D (56)**. The average rating for EPCs in Scotland is **band D (61)**.

The potential rating shows the effect of undertaking all of the improvement measures listed within your recommendations report.

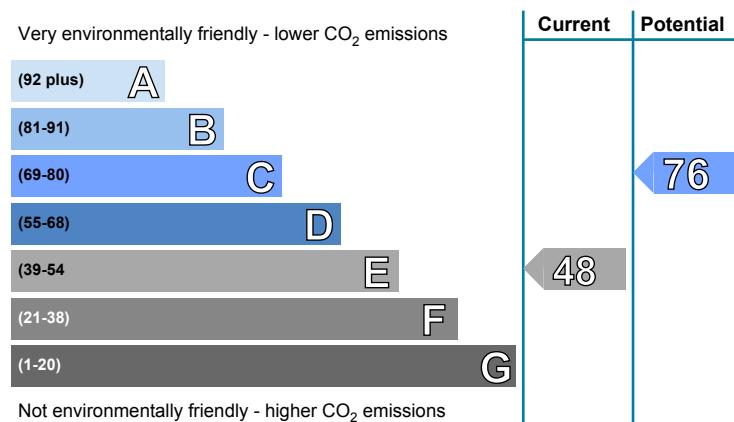
## Environmental Impact (CO<sub>2</sub>) Rating

This graph shows the effect of your home on the environment in terms of carbon dioxide (CO<sub>2</sub>) emissions. The higher the rating, the less impact it has on the environment.

Your current rating is **band E (48)**. The average rating for EPCs in Scotland is **band D (59)**.

The potential rating shows the effect of undertaking all of the improvement measures listed within your recommendations report.
