16 Gerry Square,  
Thurso,  
KW14 8BH

# Home Report

# Single Survey

| <b>Property Address</b> | 16 Gerry Square,<br>Thurso,<br>KW14 8BH |

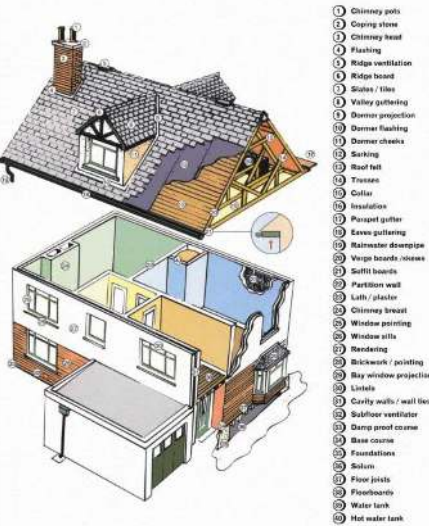
Sectional Diagram showing elements of a typical house

Reference may be made in this report to some or all of the above component parts of the property. This diagram may assist you in locating and understanding these items.
