Home Report

Single Survey

25 St Clair Avenue,
Scrabster,
Thurso,
Caithness,
KW14 7UR

SINGLE SURVEY TERMS AND CONDITIONS (WITH MVR)

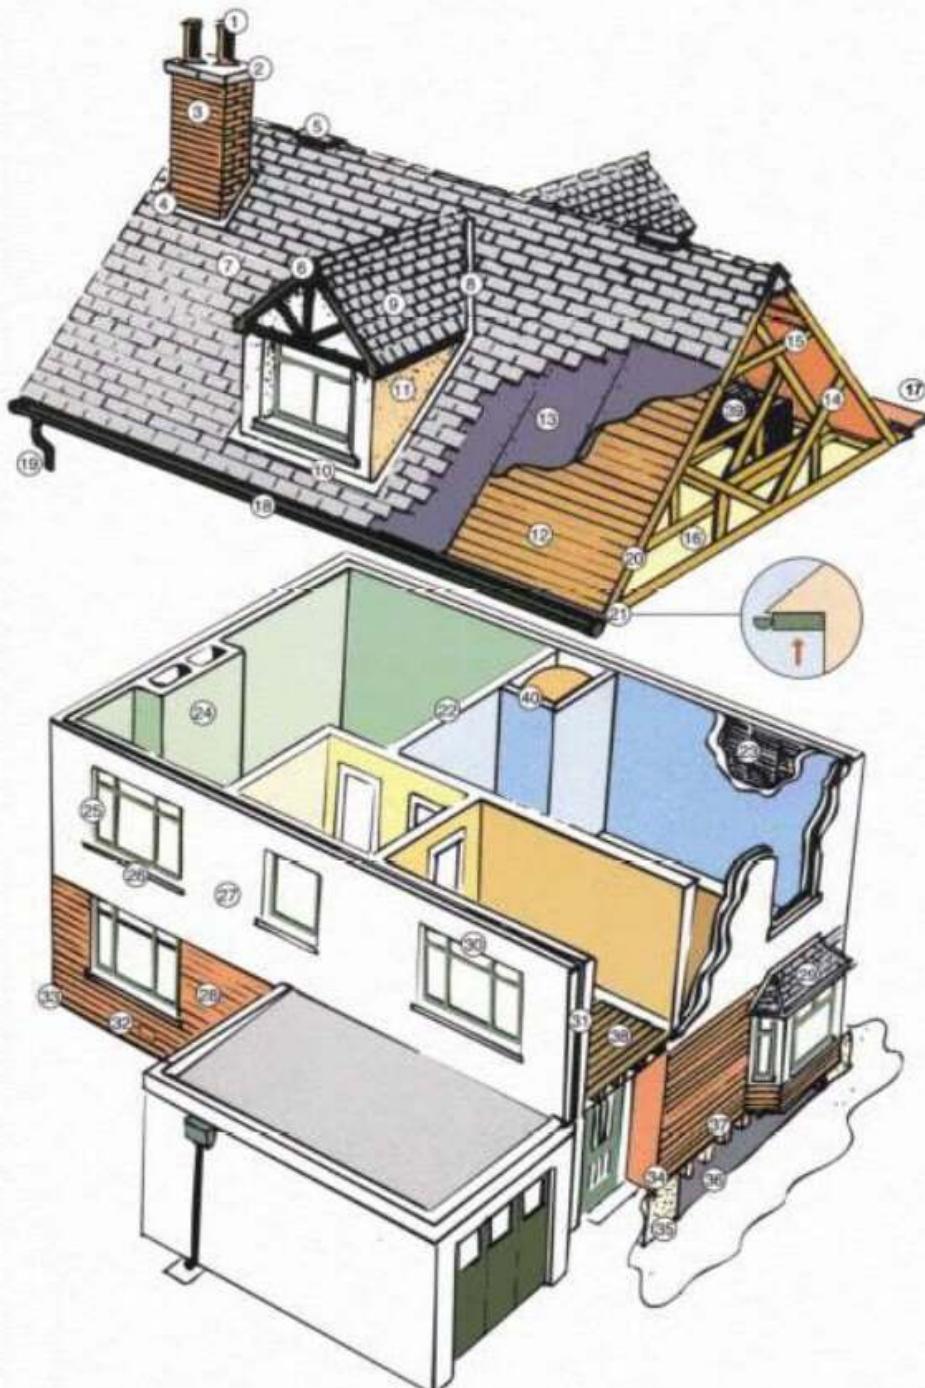
Sectional Diagram showing elements of a typical house

- 1 Chimney pots
- 2 Coping stone
- 3 Chimney head
- 4 Flashing
- 5 Ridge ventilation
- 6 Ridge board
- 7 Slates / tiles
- 8 Valley guttering
- 9 Dormer projection
- 10 Dormer flashing
- 11 Dormer cheeks
- 12 Sarking
- 13 Roof felt
- 14 Trusses
- 15 Collar
- 16 Insulation
- 17 Parapet gutter
- 18 Eaves guttering
- 19 Rainwater downpipe
- 20 Verge boards / skewers
- 21 Soffit boards
- 22 Partition wall
- 23 Lath / plaster
- 24 Chimney breast
- 25 Window pointing
- 26 Window sills
- 27 Rendering
- 28 Brickwork / pointing
- 29 Bay window projection
- 30 Lintels
- 31 Cavity walls / wall ties
- 32 Subfloor ventilator
- 33 Damp proof course
- 34 Base course
- 35 Foundations
- 36 Solum
- 37 Floor joists
- 38 Floorboards
- 39 Water tank
- 40 Hot water tank

Reference may be made in this report to some or all of the above component parts of the property. This diagram may assist you in locating and understanding these items.

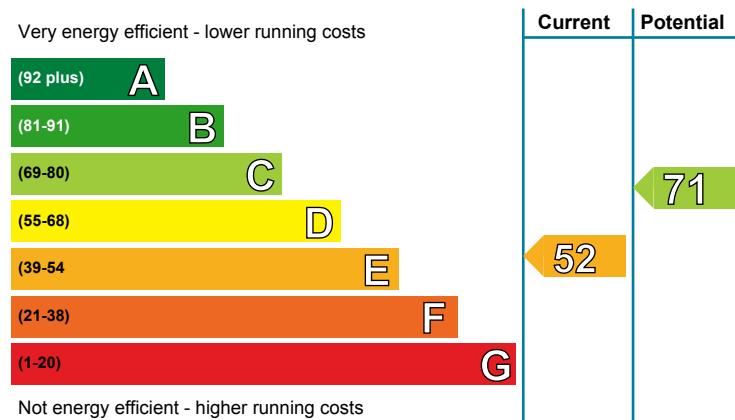
Energy Efficiency Rating

This graph shows the current efficiency of your home, taking into account both energy efficiency and fuel costs. The higher this rating, the lower your fuel bills are likely to be.

Your current rating is **band E (52)**. The average rating for EPCs in Scotland is **band D (61)**.

The potential rating shows the effect of undertaking all of the improvement measures listed within your recommendations report.

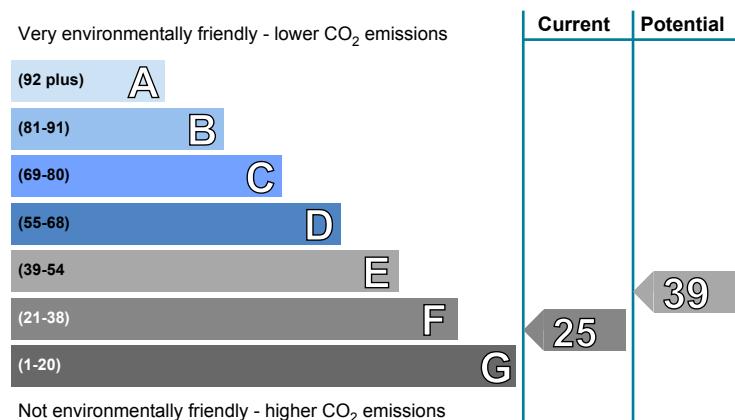
Environmental Impact (CO₂) Rating

This graph shows the effect of your home on the environment in terms of carbon dioxide (CO₂) emissions. The higher the rating, the less impact it has on the environment.
