Home Report

51 Kinstone Avenue,
Glasgow,
G14 0EB

Single Survey

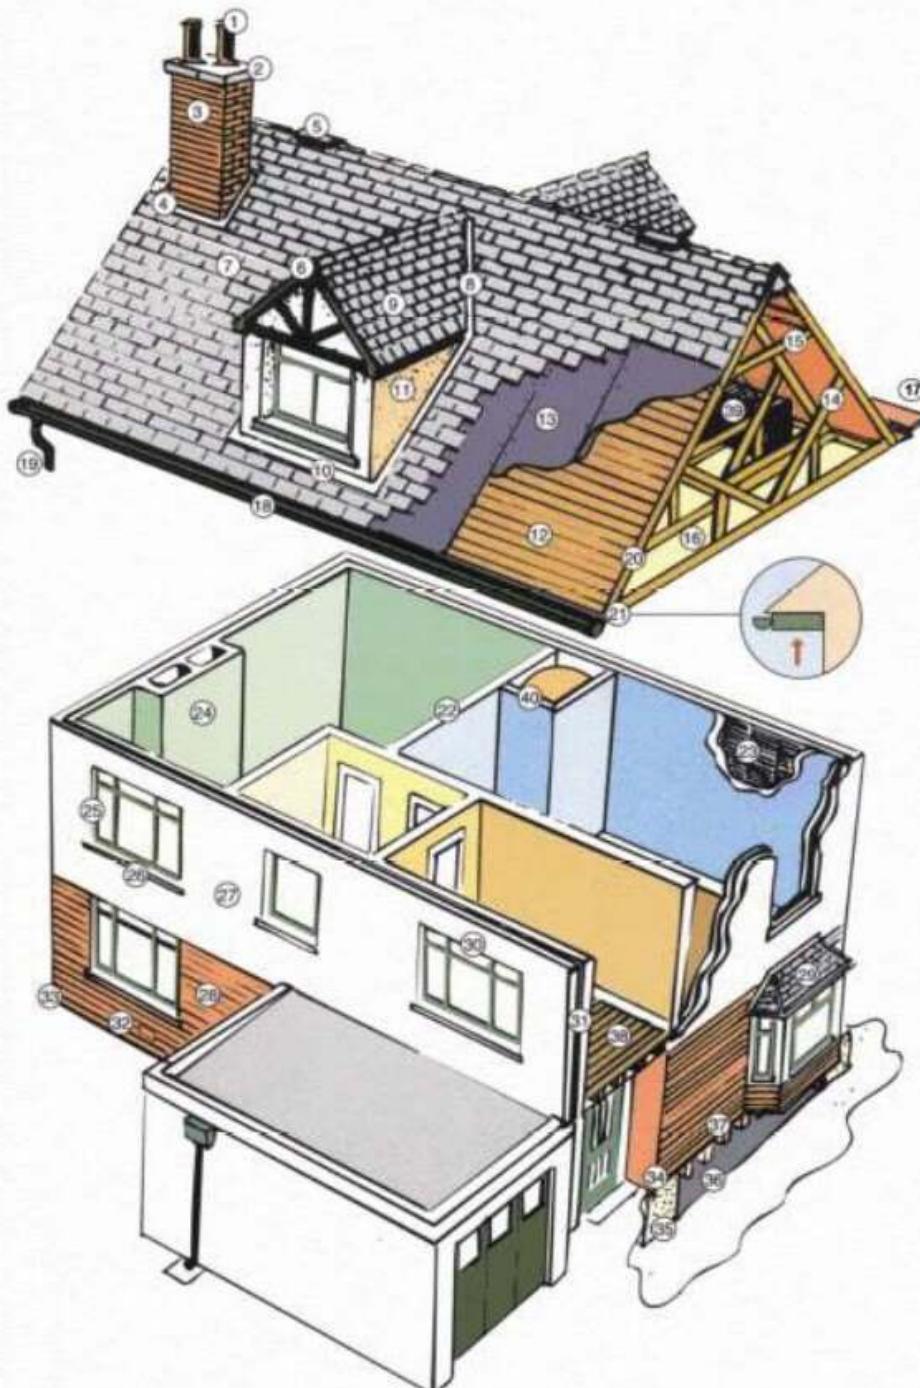
Sectional Diagram showing elements of a typical house

- 1 Chimney pots
- 2 Coping stone
- 3 Chimney head
- 4 Flashing
- 5 Ridge ventilation
- 6 Ridge board
- 7 Slates / tiles
- 8 Valley guttering
- 9 Dormer projection
- 10 Dormer flashing
- 11 Dormer cheeks
- 12 Sarking
- 13 Roof felt
- 14 Trusses
- 15 Collar
- 16 Insulation
- 17 Parapet gutter
- 18 Eaves guttering
- 19 Rainwater downpipe
- 20 Verge boards / skewers
- 21 Soffit boards
- 22 Partition wall
- 23 Lath / plaster
- 24 Chimney breast
- 25 Window pointing
- 26 Window sills
- 27 Rendering
- 28 Brickwork / pointing
- 29 Bay window projection
- 30 Lintels
- 31 Cavity walls / wall ties
- 32 Subfloor ventilator
- 33 Damp proof course
- 34 Base course
- 35 Foundations
- 36 Solum
- 37 Floor joists
- 38 Floorboards
- 39 Water tank
- 40 Hot water tank

Reference may be made in this report to some or all of the above component parts of the property. This diagram may assist you in locating and understanding these items.
