Home Report

Single Survey

Property address	3/2 12 Castlebank Place Glasgow G11 6BW
Customer	M Jethwa
Customer address	3/2 12 Castlebank Place Glasgow G11 6BW
Prepared by	Shepherd Chartered Surveyors
Date of inspection	13/01/2026

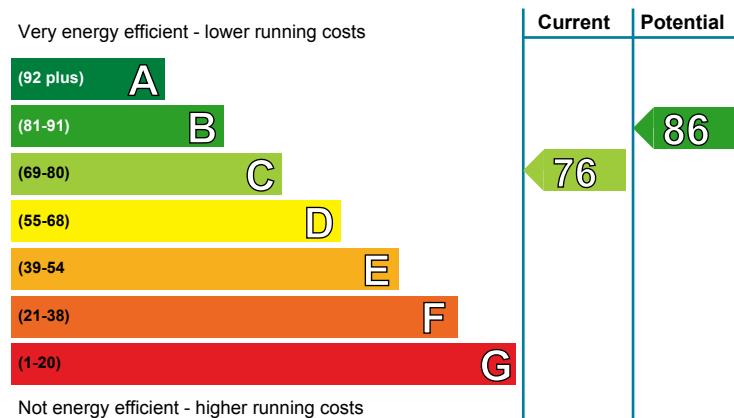
Energy Efficiency Rating

This graph shows the current efficiency of your home, taking into account both energy efficiency and fuel costs. The higher this rating, the lower your fuel bills are likely to be.

Your current rating is **band C (76)**. The average rating for EPCs in Scotland is **band D (61)**.

The potential rating shows the effect of undertaking all of the improvement measures listed within your recommendations report.

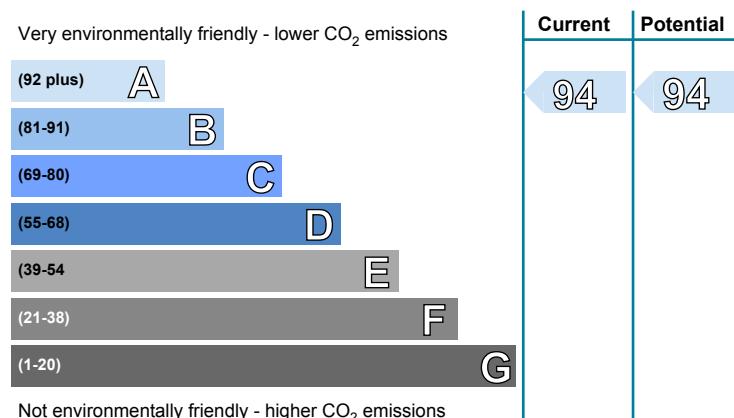
Environmental Impact (CO₂) Rating

This graph shows the effect of your home on the environment in terms of carbon dioxide (CO₂) emissions. The higher the rating, the less impact it has on the environment.
