# HOME REPORT

28 GLENBURN STREET  
GLASGOW  
G20 0RG

# ENERGY PERFORMANCE CERTIFICATE

# Single Survey

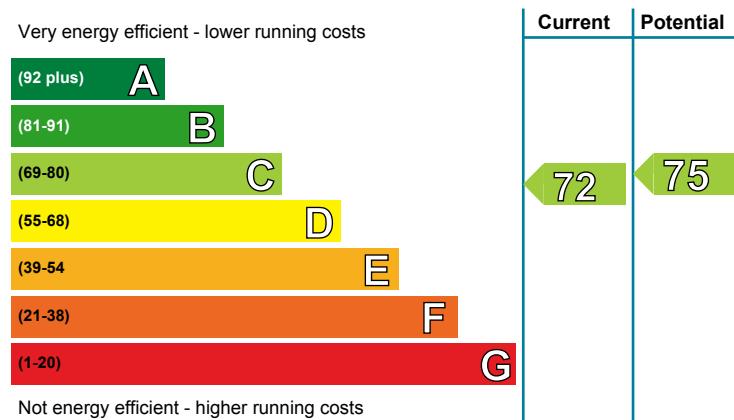
## Energy Efficiency Rating

This graph shows the current efficiency of your home, taking into account both energy efficiency and fuel costs. The higher this rating, the lower your fuel bills are likely to be.

Your current rating is **band C (72)**. The average rating for EPCs in Scotland is **band D (61)**.

The potential rating shows the effect of undertaking all of the improvement measures listed within your recommendations report.
