FLAT 1/2  
4 PRIMROSE STREET  
GLASGOW  
G14 0TE

# Home Report

# Scottish Single Survey

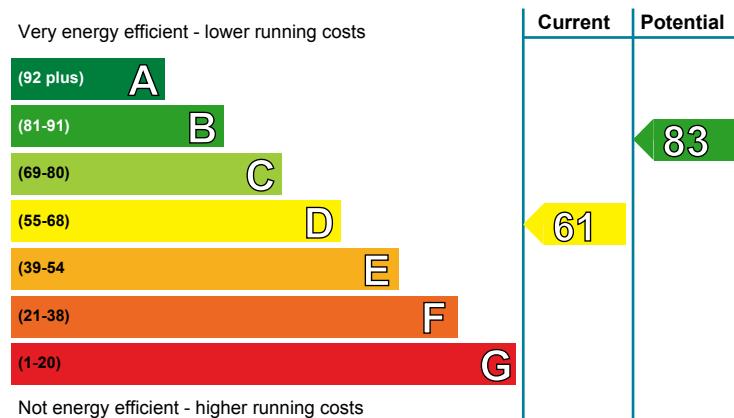
## Energy Efficiency Rating

This graph shows the current efficiency of your home, taking into account both energy efficiency and fuel costs. The higher this rating, the lower your fuel bills are likely to be.

Your current rating is **band D (61)**. The average rating for EPCs in Scotland is **band D (61)**.

The potential rating shows the effect of undertaking all of the improvement measures listed within your recommendations report.

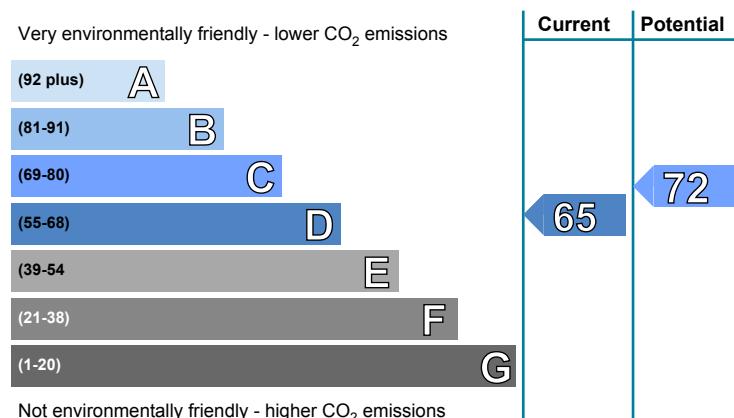
## Environmental Impact (CO<sub>2</sub>) Rating

This graph shows the effect of your home on the environment in terms of carbon dioxide (CO<sub>2</sub>) emissions. The higher the rating, the less impact it has on the environment.

Your current rating is **band D (65)**. The average rating for EPCs in Scotland is **band D (59)**.

The potential rating shows the effect of undertaking all of the improvement measures listed within your recommendations report.
