Home Report

Single Survey

Property address	22 Florence Street Greenock PA16 7JY
Customer	Client of Invest in Scottish Properties
Customer address	22 Florence Street Greenock PA16 7JY
Prepared by	Select Surveyors Ltd
Date of Inspection	2 nd March 2022

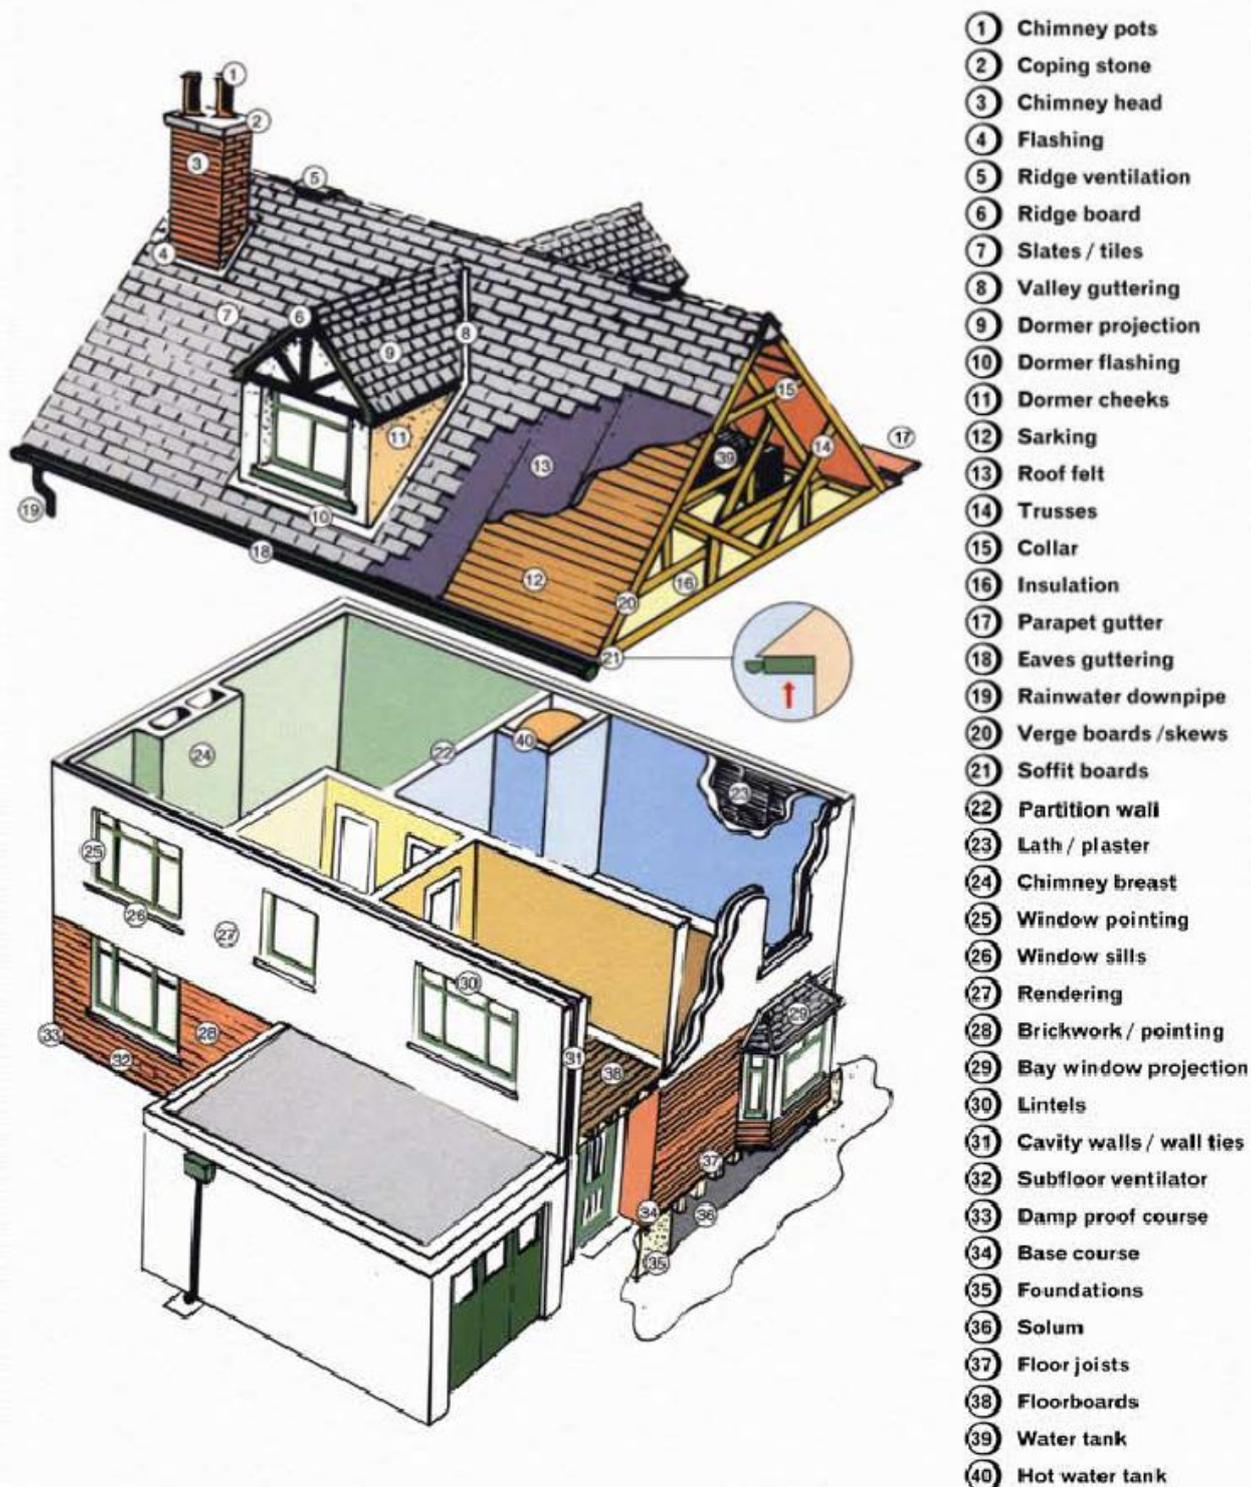
Sectional Diagram showing elements of a typical house

Reference may be made in this report to some or all of the above component parts of the property. This diagram may assist you in locating and understanding these items.

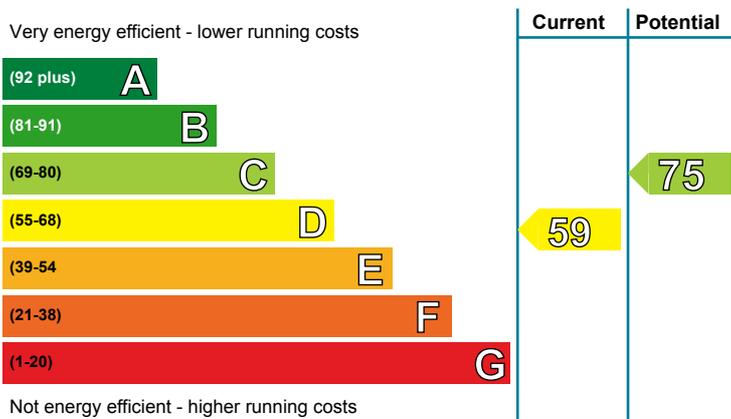
Energy Efficiency Rating

This graph shows the current efficiency of your home, taking into account both energy efficiency and fuel costs. The higher this rating, the lower your fuel bills are likely to be.

Your current rating is **band D (59)**. The average rating for EPCs in Scotland is **band D (61)**.

The potential rating shows the effect of undertaking all of the improvement measures listed within your recommendations report.

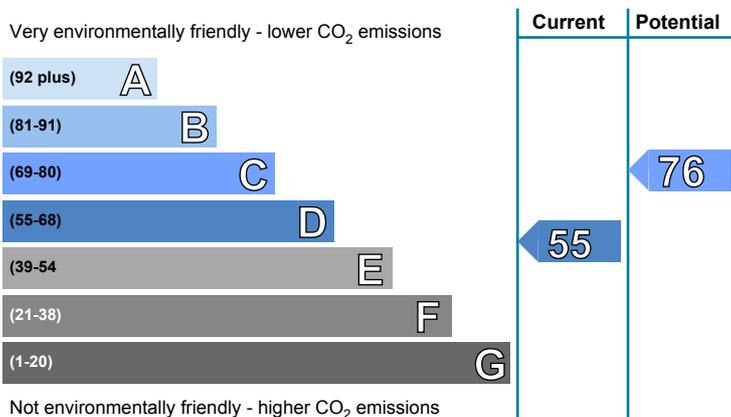
Environmental Impact (CO₂) Rating

This graph shows the effect of your home on the environment in terms of carbon dioxide (CO₂) emissions. The higher the rating, the less impact it has on the environment.
