Home Report

42 Curling Crescent,
Glasgow,
G44 4QH

Single Survey

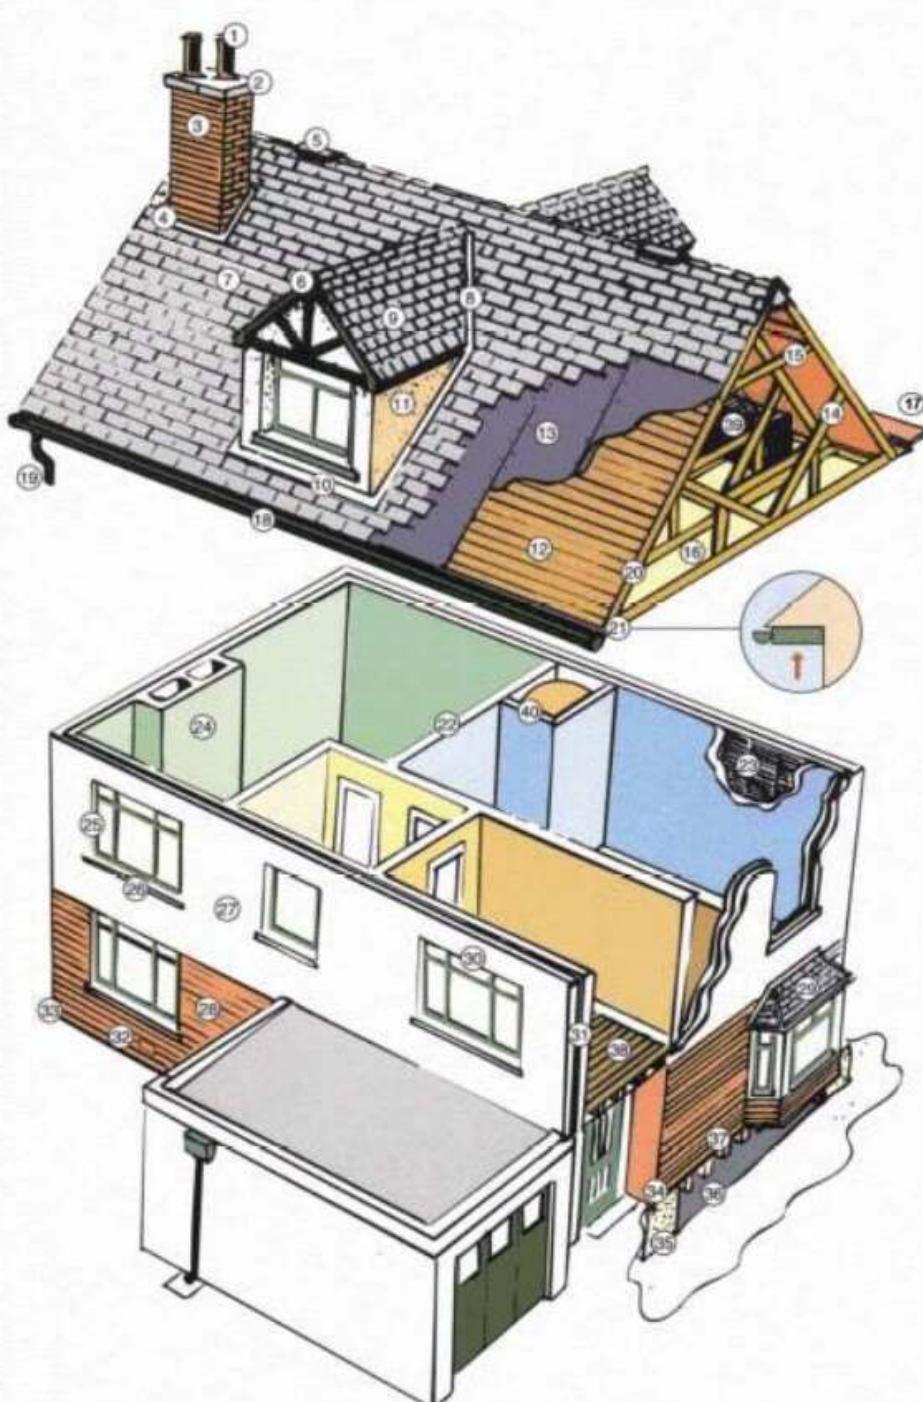
Sectional Diagram showing elements of a typical house

- 1 Chimney pots
- 2 Coping stone
- 3 Chimney head
- 4 Flashing
- 5 Ridge ventilation
- 6 Ridge board
- 7 Slates / tiles
- 8 Valley guttering
- 9 Dormer projection
- 10 Dormer flashing
- 11 Dormer cheeks
- 12 Sarking
- 13 Roof felt
- 14 Trusses
- 15 Collar
- 16 Insulation
- 17 Parapet gutter
- 18 Eaves guttering
- 19 Rainwater downpipe
- 20 Verge boards / skewers
- 21 Soffit boards
- 22 Partition wall
- 23 Lath / plaster
- 24 Chimney breast
- 25 Window pointing
- 26 Window sills
- 27 Rendering
- 28 Brickwork / pointing
- 29 Bay window projection
- 30 Lintels
- 31 Cavity walls / wall ties
- 32 Subfloor ventilator
- 33 Damp proof course
- 34 Base course
- 35 Foundations
- 36 Solum
- 37 Floor joists
- 38 Floorboards
- 39 Water tank
- 40 Hot water tank

Reference may be made in this report to some or all of the above component parts of the property. This diagram may assist you in locating and understanding these items.

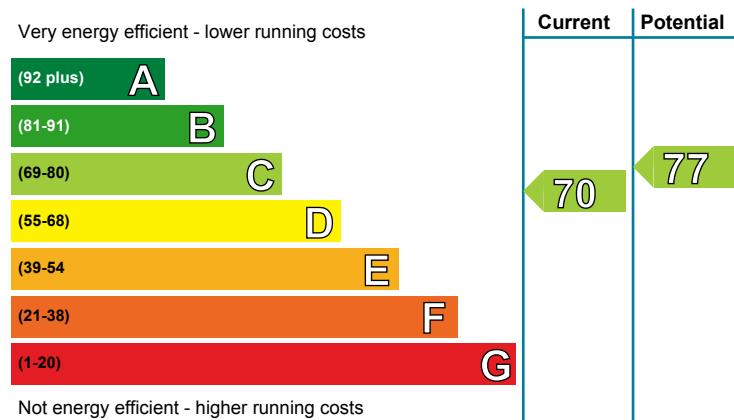
Energy Efficiency Rating

This graph shows the current efficiency of your home, taking into account both energy efficiency and fuel costs. The higher this rating, the lower your fuel bills are likely to be.

Your current rating is **band C (70)**. The average rating for EPCs in Scotland is **band D (61)**.

The potential rating shows the effect of undertaking all of the improvement measures listed within your recommendations report.

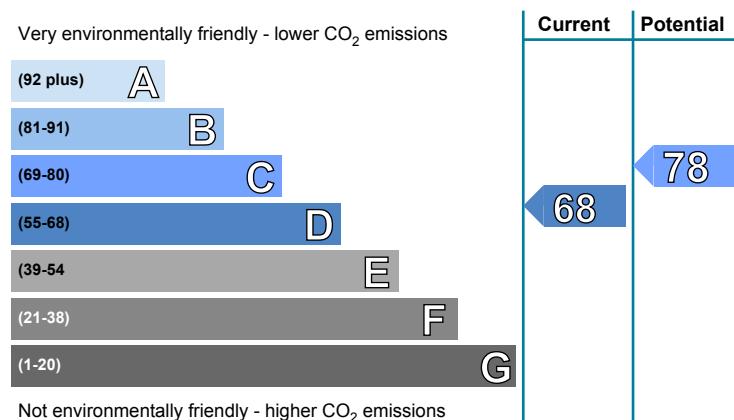
Environmental Impact (CO₂) Rating

This graph shows the effect of your home on the environment in terms of carbon dioxide (CO₂) emissions. The higher the rating, the less impact it has on the environment.
