81 FOWLERS COURT  
PRESTONPANS  
EH32 9AT

# Home Report

# Energy Performance Certificate

# Scottish Single Survey

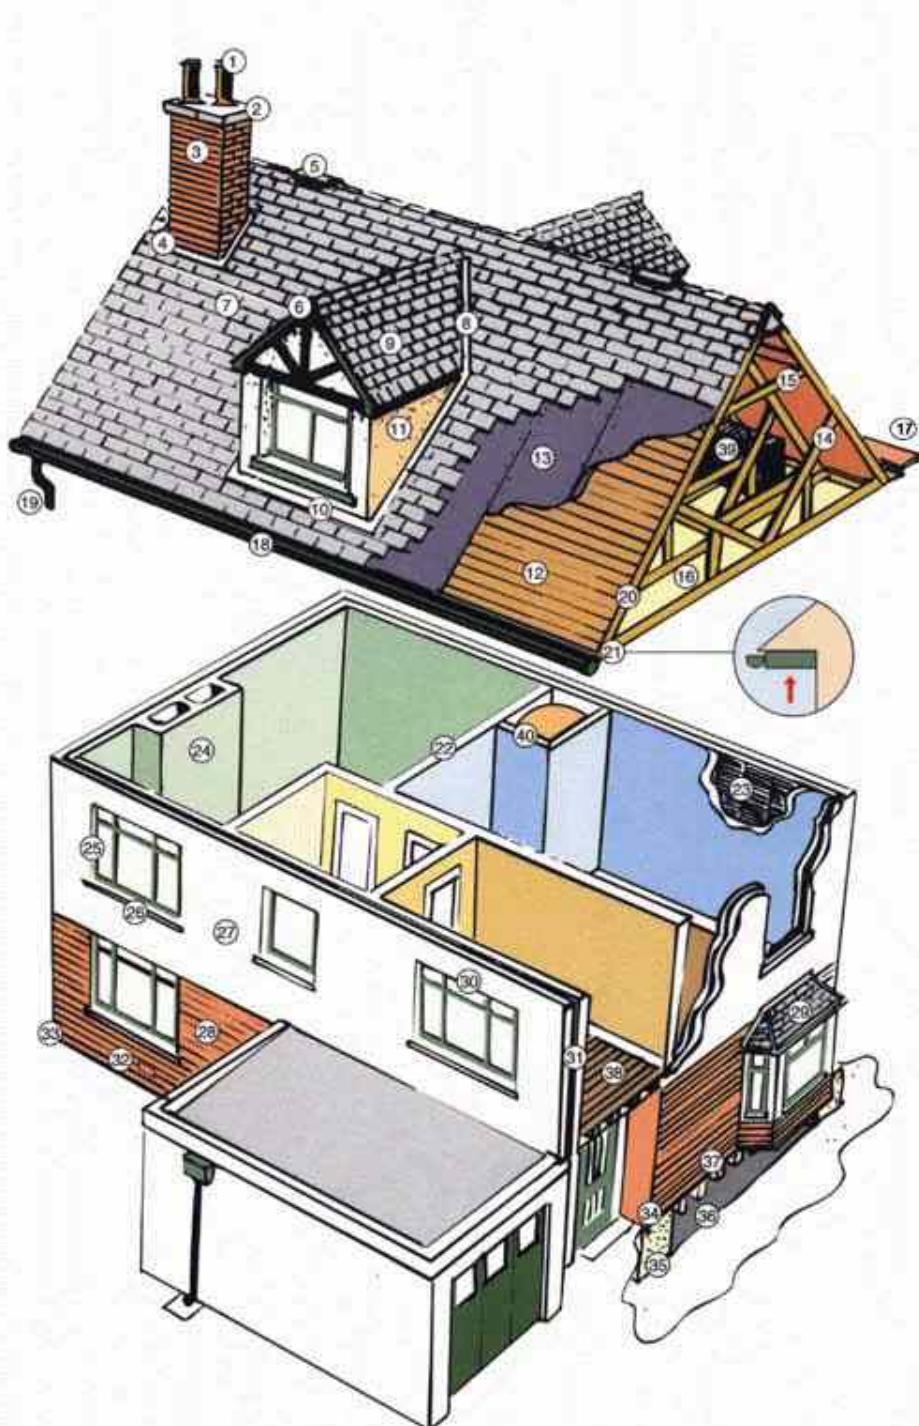
## Sectional Diagram showing elements of a typical house

- 1 Chimney pots
- 2 Coping stone
- 3 Chimney head
- 4 Flashing
- 5 Ridge ventilation
- 6 Ridge board
- 7 Slates / tiles
- 8 Valley guttering
- 9 Dormer projection
- 10 Dormer flashing
- 11 Dormer cheeks
- 12 Sarking
- 13 Roof felt
- 14 Trusses
- 15 Collar
- 16 Insulation
- 17 Parapet gutter
- 18 Eaves guttering
- 19 Rainwater downpipe
- 20 Verge boards /skews
- 21 Soffit boards
- 22 Partition wall
- 23 Lath / plaster
- 24 Chimney breast
- 25 Window pointing
- 26 Window sills
- 27 Rendering
- 28 Brickwork / pointing
- 29 Bay window projection
- 30 Lintels
- 31 Cavity walls / wall ties
- 32 Subfloor ventilator
- 33 Damp proof course
- 34 Base course
- 35 Foundations
- 36 Solum
- 37 Floor joists
- 38 Floorboards
- 39 Water tank
- 40 Hot water tank

Reference may be made in this report to some or all of the above component parts of the property. This diagram may assist you in locating and understanding these items.
