61 HAMILTON CRESCENT  
STEVENSTON  
KA20 4JD

# Home Report

# Energy Performance Certificate

# Scottish Single Survey

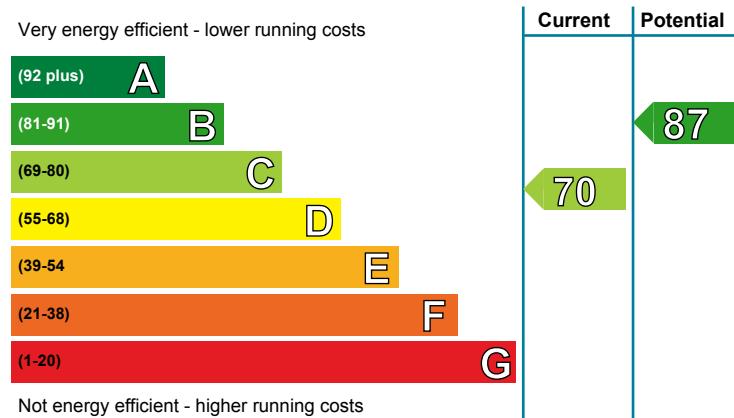
## Energy Efficiency Rating

This graph shows the current efficiency of your home, taking into account both energy efficiency and fuel costs. The higher this rating, the lower your fuel bills are likely to be.

Your current rating is **band C (70)**. The average rating for EPCs in Scotland is **band D (61)**.

The potential rating shows the effect of undertaking all of the improvement measures listed within your recommendations report.

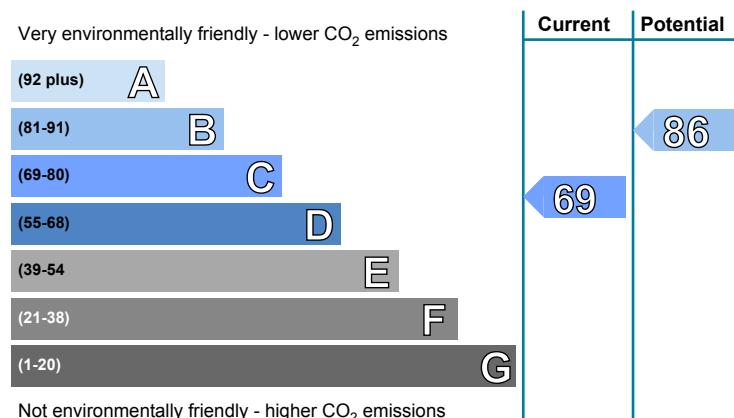
## Environmental Impact (CO<sub>2</sub>) Rating

This graph shows the effect of your home on the environment in terms of carbon dioxide (CO<sub>2</sub>) emissions. The higher the rating, the less impact it has on the environment.

Your current rating is **band C (69)**. The average rating for EPCs in Scotland is **band D (59)**.

The potential rating shows the effect of undertaking all of the improvement measures listed within your recommendations report.

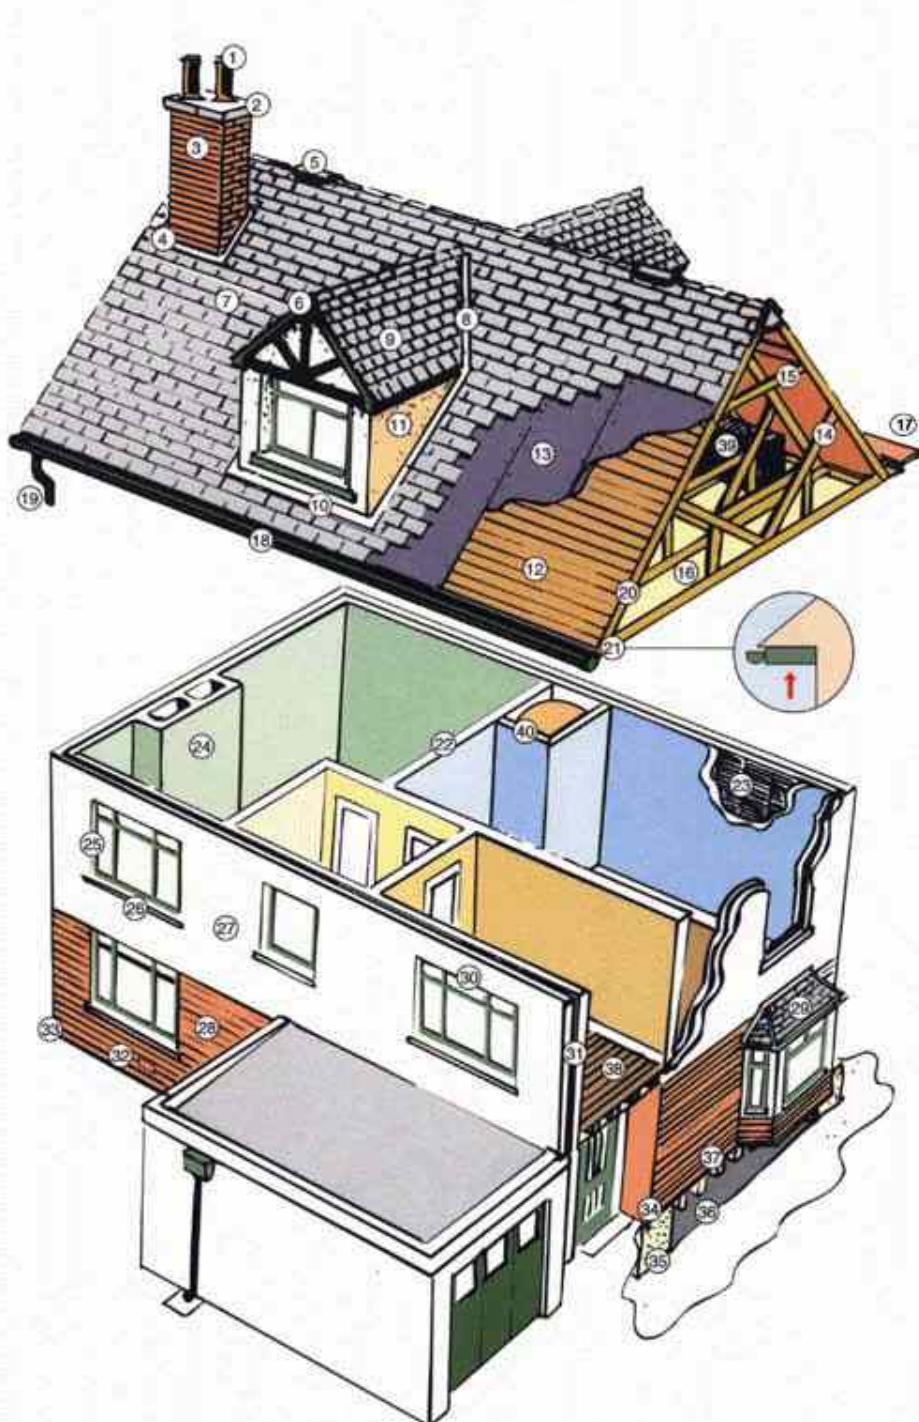
## Sectional Diagram showing elements of a typical house

- 1 Chimney pots
- 2 Coping stone
- 3 Chimney head
- 4 Flashing
- 5 Ridge ventilation
- 6 Ridge board
- 7 Slates / tiles
- 8 Valley guttering
- 9 Dormer projection
- 10 Dormer flashing
- 11 Dormer cheeks
- 12 Sarking
- 13 Roof felt
- 14 Trusses
- 15 Collar
- 16 Insulation
- 17 Parapet gutter
- 18 Eaves guttering
- 19 Rainwater downpipe
- 20 Verge boards /skews
- 21 Soffit boards
- 22 Partition wall
- 23 Lath / plaster
- 24 Chimney breast
- 25 Window pointing
- 26 Window sills
- 27 Rendering
- 28 Brickwork / pointing
- 29 Bay window projection
- 30 Lintels
- 31 Cavity walls / wall ties
- 32 Subfloor ventilator
- 33 Damp proof course
- 34 Base course
- 35 Foundations
- 36 Solum
- 37 Floor joists
- 38 Floorboards
- 39 Water tank
- 40 Hot water tank

Reference may be made in this report to some or all of the above component parts of the property. This diagram may assist you in locating and understanding these items.
