86 CURLING CRESCENT  
GLASGOW  
G44 4QQ

# Home Report

# Energy Performance Certificate

# Scottish Single Survey

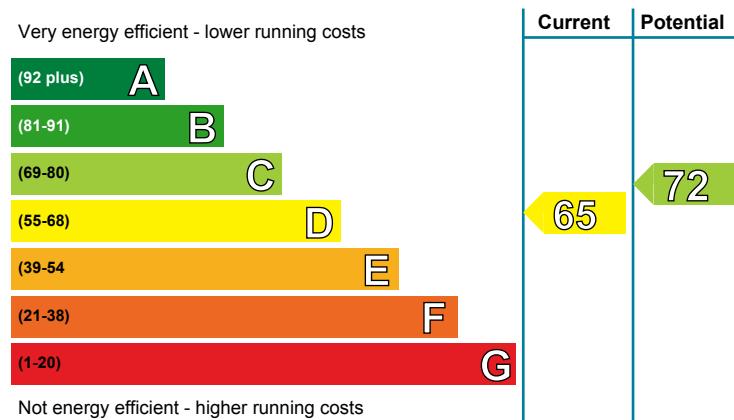
## Energy Efficiency Rating

This graph shows the current efficiency of your home, taking into account both energy efficiency and fuel costs. The higher this rating, the lower your fuel bills are likely to be.

Your current rating is **band D (65)**. The average rating for EPCs in Scotland is **band D (61)**.

The potential rating shows the effect of undertaking all of the improvement measures listed within your recommendations report.

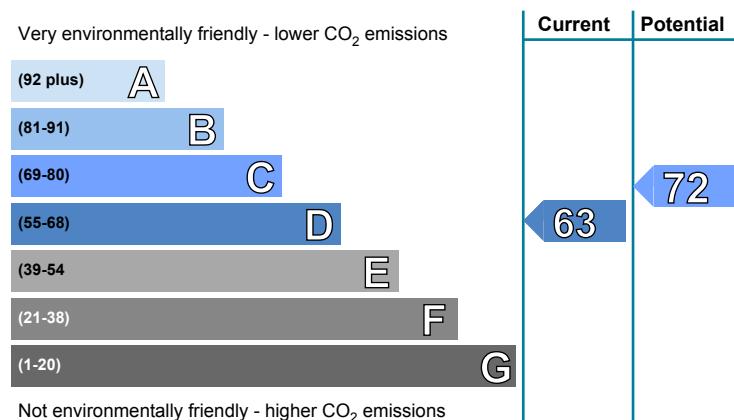
## Environmental Impact (CO<sub>2</sub>) Rating

This graph shows the effect of your home on the environment in terms of carbon dioxide (CO<sub>2</sub>) emissions. The higher the rating, the less impact it has on the environment.

Your current rating is **band D (63)**. The average rating for EPCs in Scotland is **band D (59)**.

The potential rating shows the effect of undertaking all of the improvement measures listed within your recommendations report.

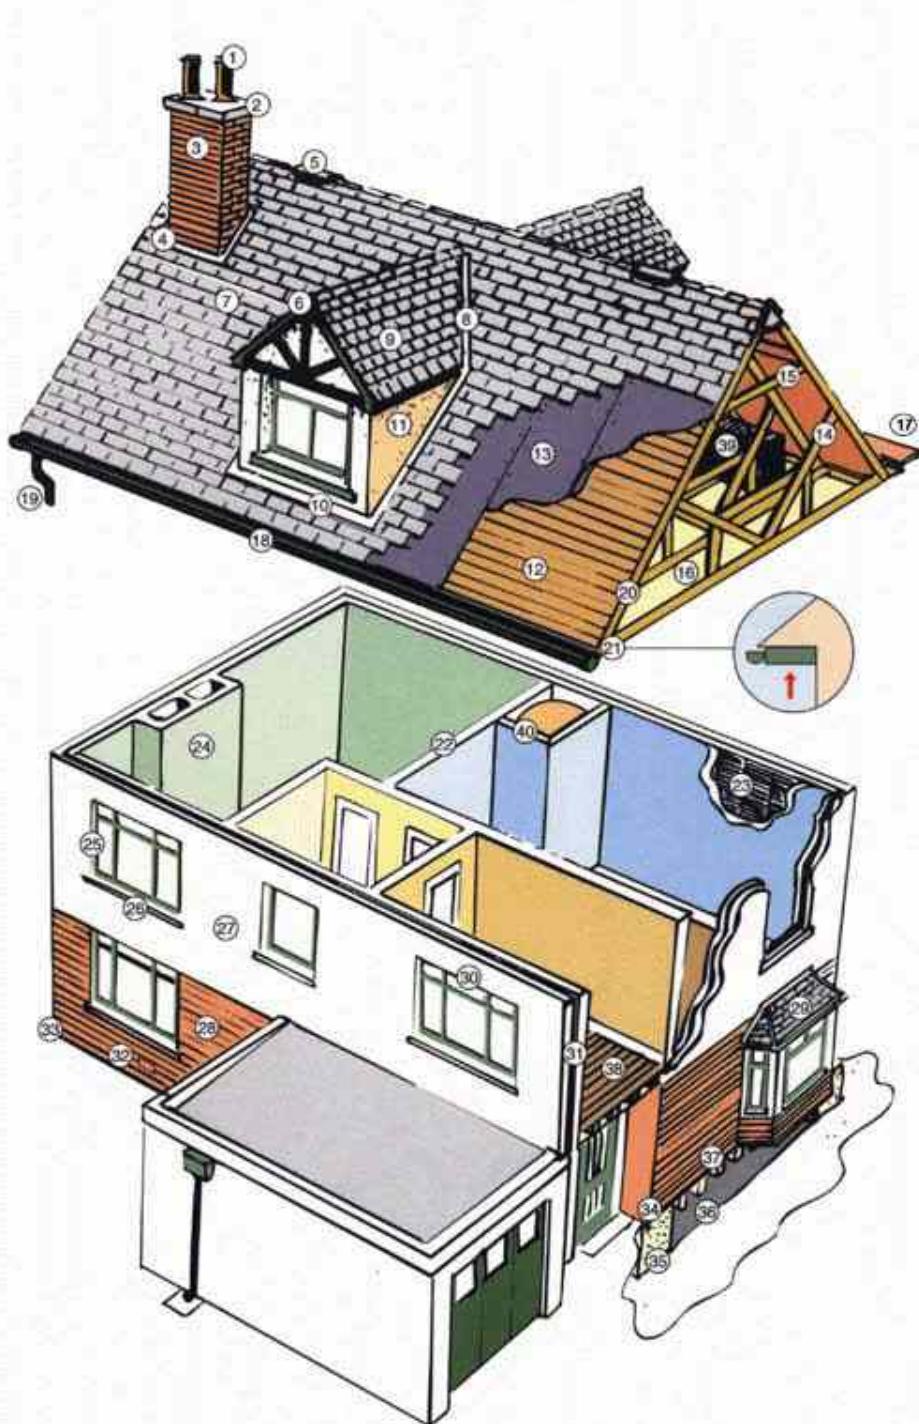
## Sectional Diagram showing elements of a typical house

- 1 Chimney pots
- 2 Coping stone
- 3 Chimney head
- 4 Flashing
- 5 Ridge ventilation
- 6 Ridge board
- 7 Slates / tiles
- 8 Valley guttering
- 9 Dormer projection
- 10 Dormer flashing
- 11 Dormer cheeks
- 12 Sarking
- 13 Roof felt
- 14 Trusses
- 15 Collar
- 16 Insulation
- 17 Parapet gutter
- 18 Eaves guttering
- 19 Rainwater downpipe
- 20 Verge boards /skews
- 21 Soffit boards
- 22 Partition wall
- 23 Lath / plaster
- 24 Chimney breast
- 25 Window pointing
- 26 Window sills
- 27 Rendering
- 28 Brickwork / pointing
- 29 Bay window projection
- 30 Lintels
- 31 Cavity walls / wall ties
- 32 Subfloor ventilator
- 33 Damp proof course
- 34 Base course
- 35 Foundations
- 36 Solum
- 37 Floor joists
- 38 Floorboards
- 39 Water tank
- 40 Hot water tank

Reference may be made in this report to some or all of the above component parts of the property. This diagram may assist you in locating and understanding these items.
