HOME
report

SINGLE SURVEY
ENERGY REPORT
PROPERTY QUESTIONNAIRE
VALUATION REPORT

Survey report on:

Property Address	Flat 1/3 3 Scotstoun Street Glasgow G14 0TA
Customer	Mr S McBride
Date of Inspection	16/01/2024
Prepared by	Brett G McMillan Harvey Donaldson & Gibson Chartered Surveyors

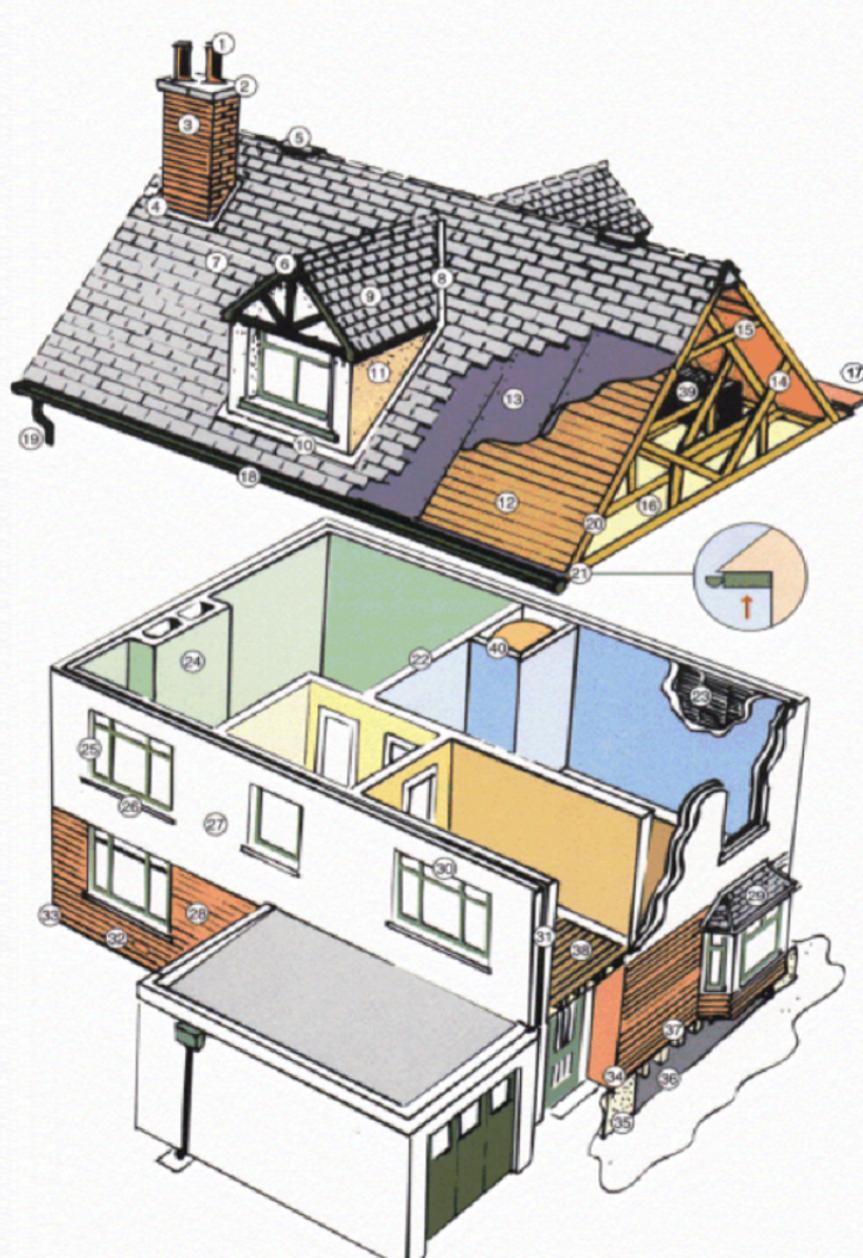
Sectional Diagram showing elements of a typical house

- ① Chimney pots
- ② Coping stone
- ③ Chimney head
- ④ Flashing
- ⑤ Ridge ventilation
- ⑥ Ridge board
- ⑦ Slates / tiles
- ⑧ Valley guttering
- ⑨ Dormer projection
- ⑩ Dormer flashing
- ⑪ Dormer cheeks
- ⑫ Sarking
- ⑬ Roof felt
- ⑭ Trusses
- ⑮ Collar
- ⑯ Insulation
- ⑰ Parapet gutter
- ⑲ Eaves guttering
- ⑳ Rainwater downpipe
- ㉑ Verge boards / skews
- ㉒ Soffit boards
- ㉓ Partition wall
- ㉔ Lath / plaster
- ㉕ Chimney breast
- ㉖ Window pointing
- ㉗ Window sills
- ㉘ Rendering
- ㉙ Brickwork / pointing
- ㉚ Bay window projection
- ㉛ Lintels
- ㉜ Cavity walls / wall ties
- ㉝ Subfloor ventilator
- ㉞ Damp proof course
- ㉟ Base course
- ㉞ Foundations
- ㉞ Solum
- ㉞ Floor joists
- ㉞ Floorboards
- ㉞ Water tank
- ㉞ Hot water tank

Reference may be made in this report to some or all of the above component parts of the property. This diagram may assist you in locating and understanding these items.

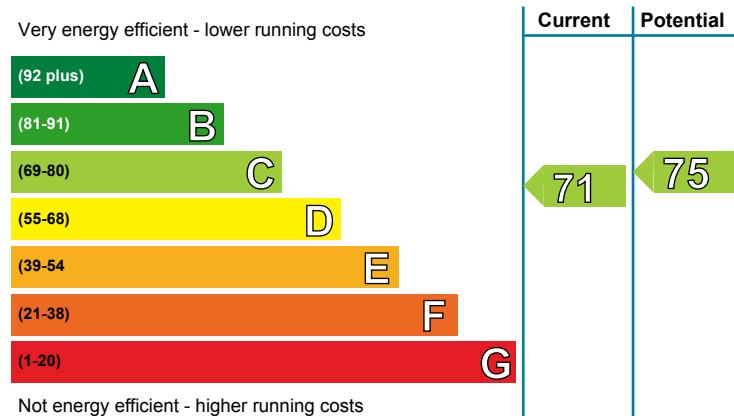
Energy Efficiency Rating

This graph shows the current efficiency of your home, taking into account both energy efficiency and fuel costs. The higher this rating, the lower your fuel bills are likely to be.

Your current rating is **band C (71)**. The average rating for EPCs in Scotland is **band D (61)**.

The potential rating shows the effect of undertaking all of the improvement measures listed within your recommendations report.

Estimated energy costs for your home for 3 years*	£2,307	See your recommendations report for more information
Over 3 years you could save*	£360

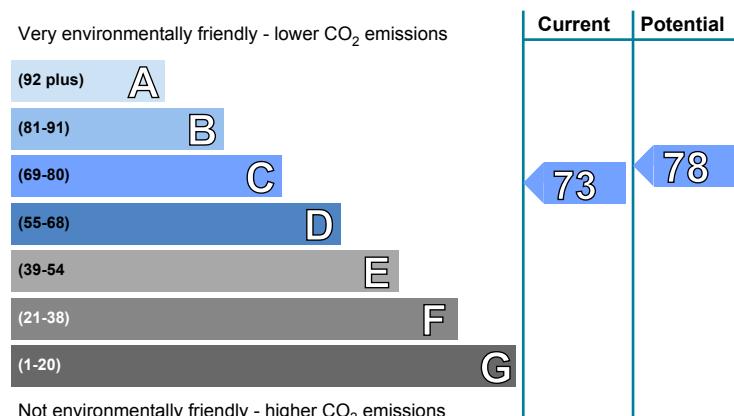
Environmental Impact (CO₂) Rating

This graph shows the effect of your home on the environment in terms of carbon dioxide (CO₂) emissions. The higher the rating, the less impact it has on the environment.
