HOME REPORT

31 CAROUSEL CRESCENT
WISHAW
ML2 7ER

ENERGY REPORT

Energy Performance Certificate (EPC)

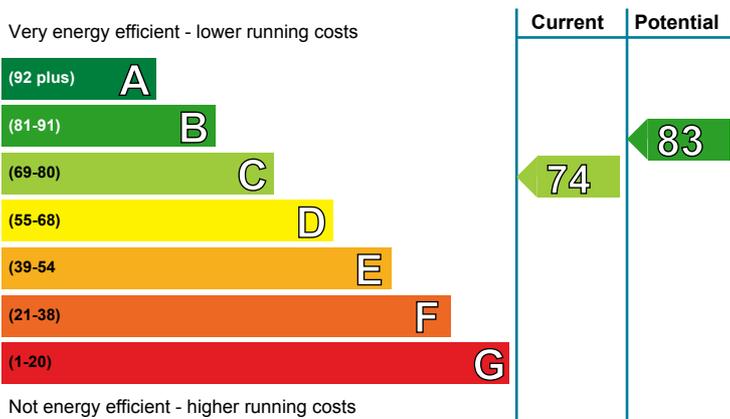
Energy Efficiency Rating

This graph shows the current efficiency of your home, taking into account both energy efficiency and fuel costs. The higher this rating, the lower your fuel bills are likely to be.

Your current rating is **band C (74)**. The average rating for EPCs in Scotland is **band D (61)**.

The potential rating shows the effect of undertaking all of the improvement measures listed within your recommendations report.

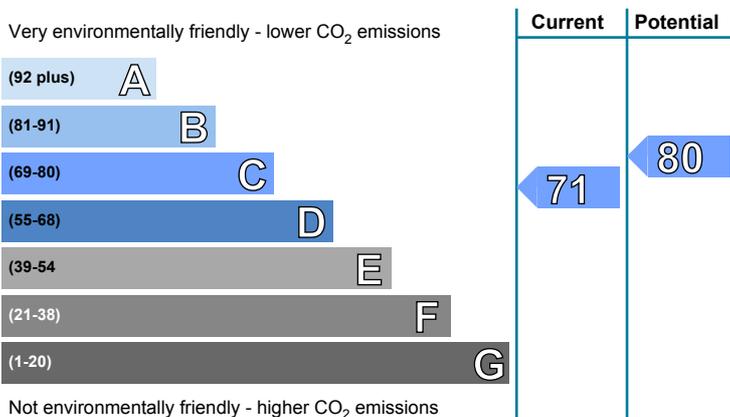
Environmental Impact (CO₂) Rating

This graph shows the effect of your home on the environment in terms of carbon dioxide (CO₂) emissions. The higher the rating, the less impact it has on the environment.

Your current rating is **band C (71)**. The average rating for EPCs in Scotland is **band D (59)**.

The potential rating shows the effect of undertaking all of the improvement measures listed within your recommendations report.
