# HOME REPORT

14 Blyth Street  
Kirkcaldy  
KY1 3HB

# SINGLE SURVEY

<b>Surveyor Reference</b>	DD0925
<b>Customer</b>	Ms. Denise Flockhart
<b>Selling address</b>	14 Blyth Street Kirkcaldy KY1 3HB
<b>Date of Inspection</b>	25/06/2024
<b>Prepared by</b>	Jonathan Combe, BSc (Hons) MRICS Dunfermline - Allied Surveyors Scotland Ltd

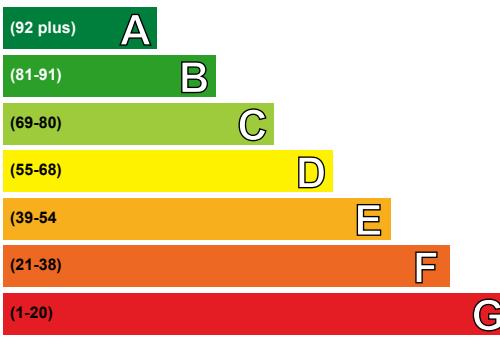
\* based upon the cost of energy for heating, hot water, lighting and ventilation, calculated using standard assumptions

Very energy efficient - lower running costs

Not energy efficient - higher running costs

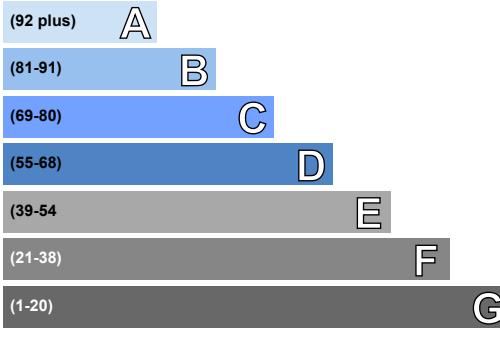
Very environmentally friendly - lower CO<sub>2</sub> emissions
