# HOME REPORT

22 KILSPINDIE CRESCENT, KIRKCALDY, KY2 6TB

# Single Survey

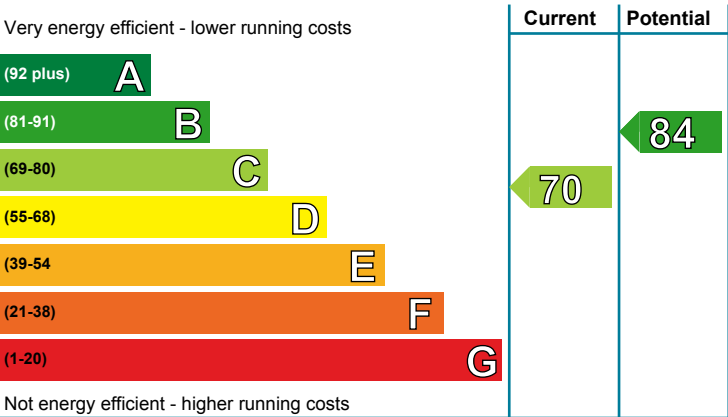
**Energy Efficiency Rating**

This graph shows the current efficiency of your home, taking into account both energy efficiency and fuel costs. The higher this rating, the lower your fuel bills are likely to be.

Your current rating is **band C (70)**. The average rating for EPCs in Scotland is **band D (61)**.

The potential rating shows the effect of undertaking all of the improvement measures listed within your recommendations report.

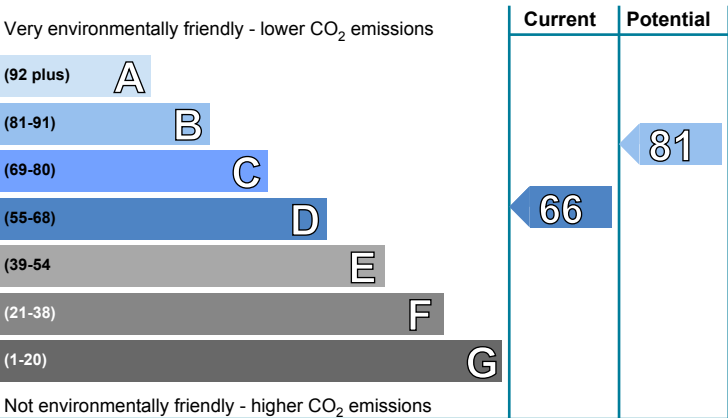
**Environmental Impact (CO<sub>2</sub>) Rating**

This graph shows the effect of your home on the environment in terms of carbon dioxide (CO<sub>2</sub>) emissions. The higher the rating, the less impact it has on the environment.

Your current rating is **band D (66)**. The average rating for EPCs in Scotland is **band D (59)**.

The potential rating shows the effect of undertaking all of the improvement measures listed within your recommendations report.
