9 Sanderson Terrace,
Auchtertool,
Kirkcaldy,
Fife,
KY2 5XN

Home Report

Single Survey

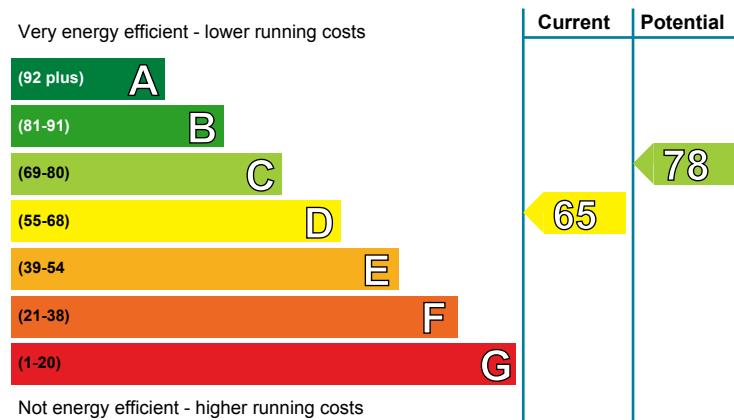
Energy Efficiency Rating

This graph shows the current efficiency of your home, taking into account both energy efficiency and fuel costs. The higher this rating, the lower your fuel bills are likely to be.

Your current rating is **band D (65)**. The average rating for EPCs in Scotland is **band D (61)**.

The potential rating shows the effect of undertaking all of the improvement measures listed within your recommendations report.
