Home Report

Scottish Single Survey

Single Survey

Property address	1 Newbigging Auchtertool Kirkcaldy KY2 5XJ
-------------------------	---

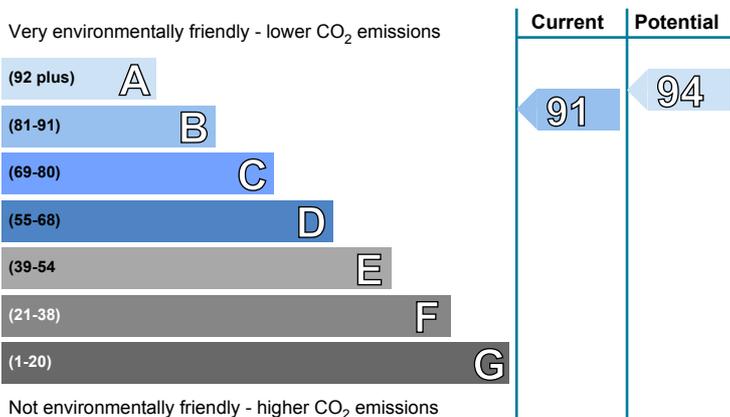
Environmental Impact (CO₂) Rating

This graph shows the effect of your home on the environment in terms of carbon dioxide (CO₂) emissions. The higher the rating, the less impact it has on the environment.
