HOME REPORT

Energy Performance Certificate (EPC)

39 TOWNSEND PLACE, KIRKCALDY, KY1 1HB

Single Survey

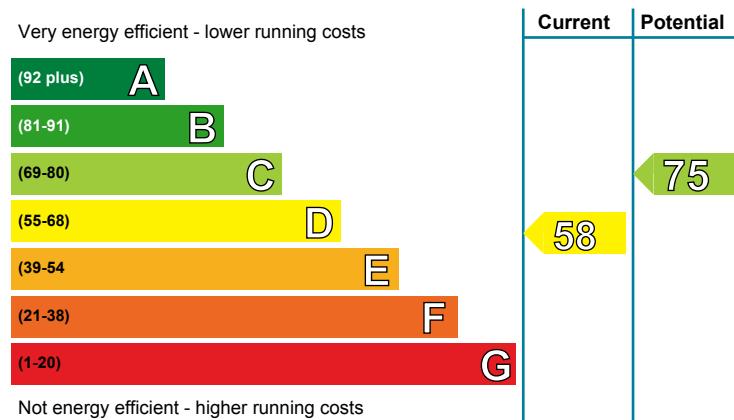
Energy Efficiency Rating

This graph shows the current efficiency of your home, taking into account both energy efficiency and fuel costs. The higher this rating, the lower your fuel bills are likely to be.

Your current rating is **band D (58)**. The average rating for EPCs in Scotland is **band D (61)**.

The potential rating shows the effect of undertaking all of the improvement measures listed within your recommendations report.

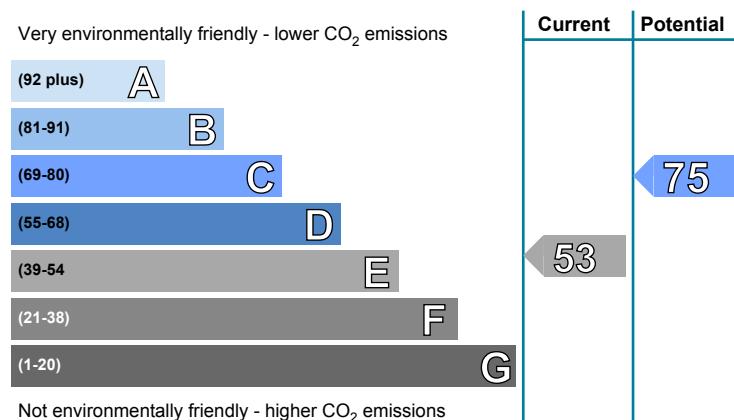
Environmental Impact (CO₂) Rating

This graph shows the effect of your home on the environment in terms of carbon dioxide (CO₂) emissions. The higher the rating, the less impact it has on the environment.

Your current rating is **band E (53)**. The average rating for EPCs in Scotland is **band D (59)**.

The potential rating shows the effect of undertaking all of the improvement measures listed within your recommendations report.
