# Home Report

# Single Survey

| <b>Property address</b> | 34 Veronica Crescent<br>Kirkcaldy<br>KY1 2LH |
| <b>Prepared by</b> | Shepherd Chartered Surveyors |

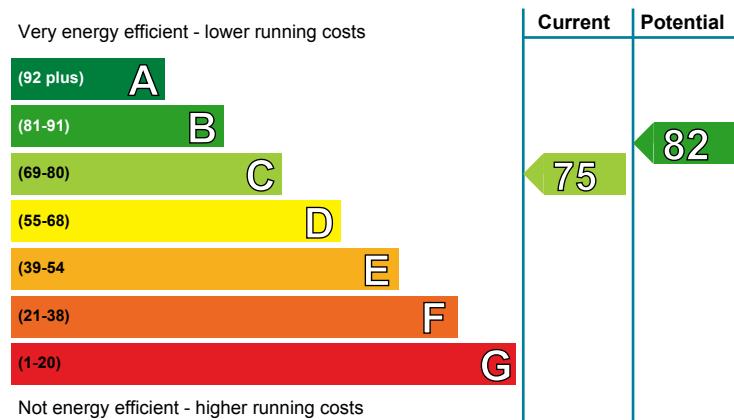
## Energy Efficiency Rating

This graph shows the current efficiency of your home, taking into account both energy efficiency and fuel costs. The higher this rating, the lower your fuel bills are likely to be.

Your current rating is **band C (75)**. The average rating for EPCs in Scotland is **band D (61)**.

The potential rating shows the effect of undertaking all of the improvement measures listed within your recommendations report.

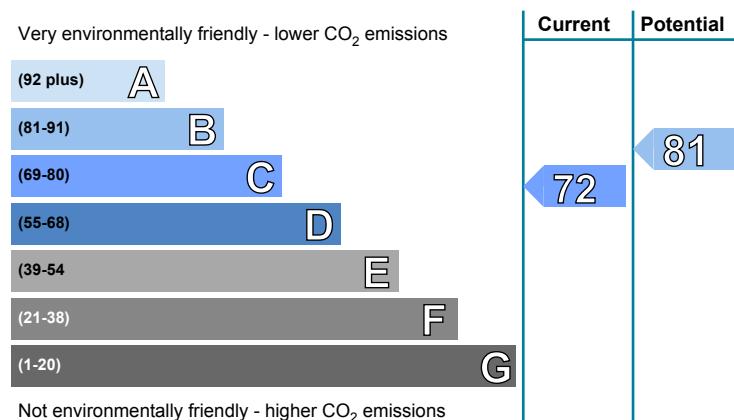
## Environmental Impact (CO<sub>2</sub>) Rating

This graph shows the effect of your home on the environment in terms of carbon dioxide (CO<sub>2</sub>) emissions. The higher the rating, the less impact it has on the environment.
