# Home Report

# Single Survey

## Survey Report on:

<b>Property Address</b>	4 Viewforth Gardens, Kirkcaldy, Fife, KY1 3DG
<b>Reference</b>	1041291
<b>Customer Name</b>	Lorna Brown
<b>Date of Inspection</b>	6th August 2025
<b>Surveyor's name, qualifications and office</b>	Ewen Sparks BSc (Hons) MRICS DM Hall LLP Chartered Surveyors 13 Wemyssfield Kirkcaldy KY1 1XN  Tel: 01592 598200  email: kirkcaldyresidential@dmhall.co.uk
<b>Prepared By</b>	DM Hall LLP

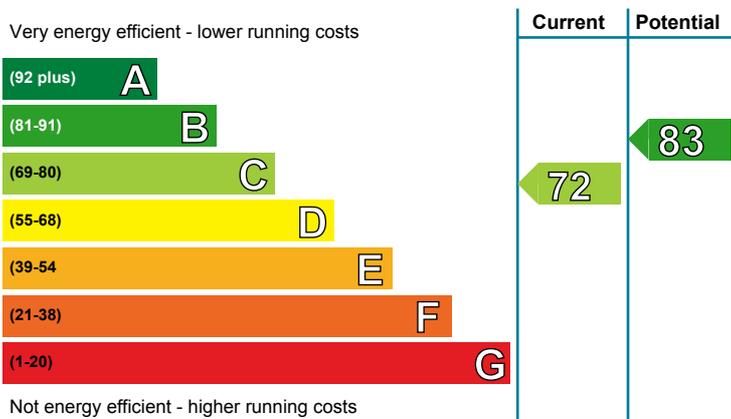
## Energy Efficiency Rating

This graph shows the current efficiency of your home, taking into account both energy efficiency and fuel costs. The higher this rating, the lower your fuel bills are likely to be.

Your current rating is **band C (72)**. The average rating for EPCs in Scotland is **band D (61)**.

The potential rating shows the effect of undertaking all of the improvement measures listed within your recommendations report.

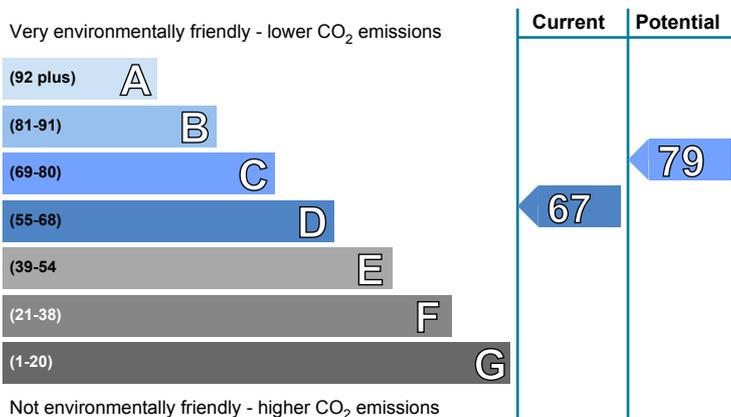
## Environmental Impact (CO<sub>2</sub>) Rating

This graph shows the effect of your home on the environment in terms of carbon dioxide (CO<sub>2</sub>) emissions. The higher the rating, the less impact it has on the environment.
