Home Report

Scottish Single Survey

Single Survey

Property address	179 Overton Road Kirkcaldy KY1 3JG
Customer	Zahid Mukhtar
Customer address	179 Overton Road Kirkcaldy KY1 3JG
Prepared by	Shepherd Chartered Surveyors
Date of inspection	15/04/2025

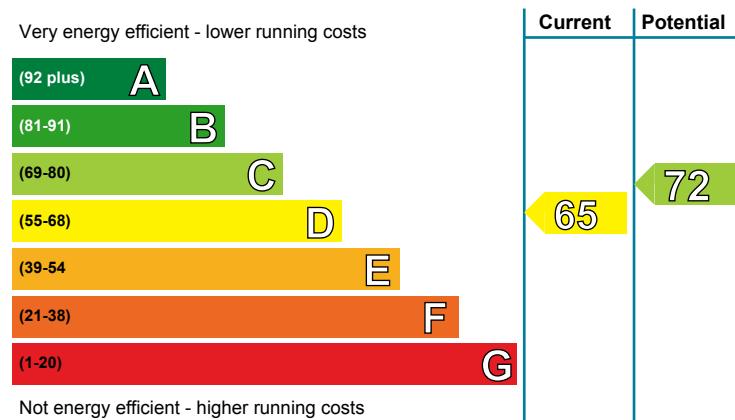
Energy Efficiency Rating

This graph shows the current efficiency of your home, taking into account both energy efficiency and fuel costs. The higher this rating, the lower your fuel bills are likely to be.

Your current rating is **band D (65)**. The average rating for EPCs in Scotland is **band D (61)**.

The potential rating shows the effect of undertaking all of the improvement measures listed within your recommendations report.

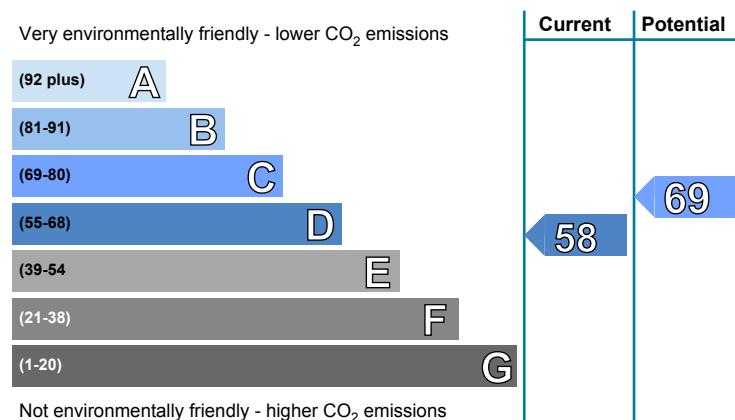
Environmental Impact (CO₂) Rating

This graph shows the effect of your home on the environment in terms of carbon dioxide (CO₂) emissions. The higher the rating, the less impact it has on the environment.
