# Home Report

# Scottish Single Survey

<b>Property address</b>	188 Aitken Road Glenrothes KY7 6SG
<b>Customer</b>	Georgie McGhie & Aidan Plenderleith
<b>Customer address</b>	188 Aitken Road Glenrothes KY7 6SG
<b>Prepared by</b>	Shepherd Chartered Surveyors
<b>Date of inspection</b>	06/03/2026

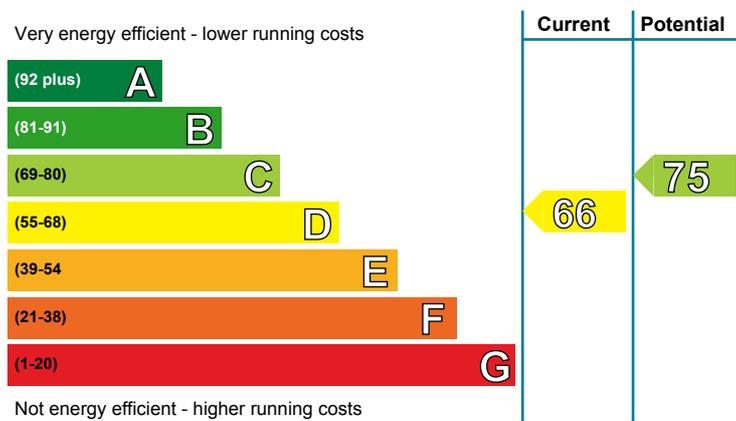
## Energy Efficiency Rating

This graph shows the current efficiency of your home, taking into account both energy efficiency and fuel costs. The higher this rating, the lower your fuel bills are likely to be.

Your current rating is **band D (66)**. The average rating for EPCs in Scotland is **band D (61)**.

The potential rating shows the effect of undertaking all of the improvement measures listed within your recommendations report.

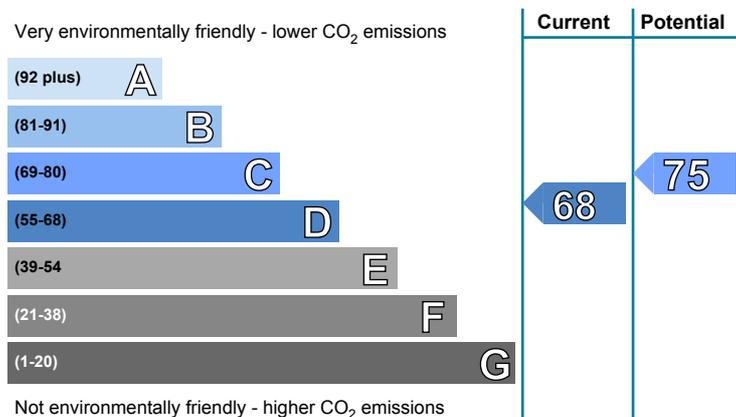
## Environmental Impact (CO<sub>2</sub>) Rating

This graph shows the effect of your home on the environment in terms of carbon dioxide (CO<sub>2</sub>) emissions. The higher the rating, the less impact it has on the environment.
