11 Woodside Way,  
Glenrothes,  
KY7 5DF

# Home Report

# Single Survey

## Survey Report on:

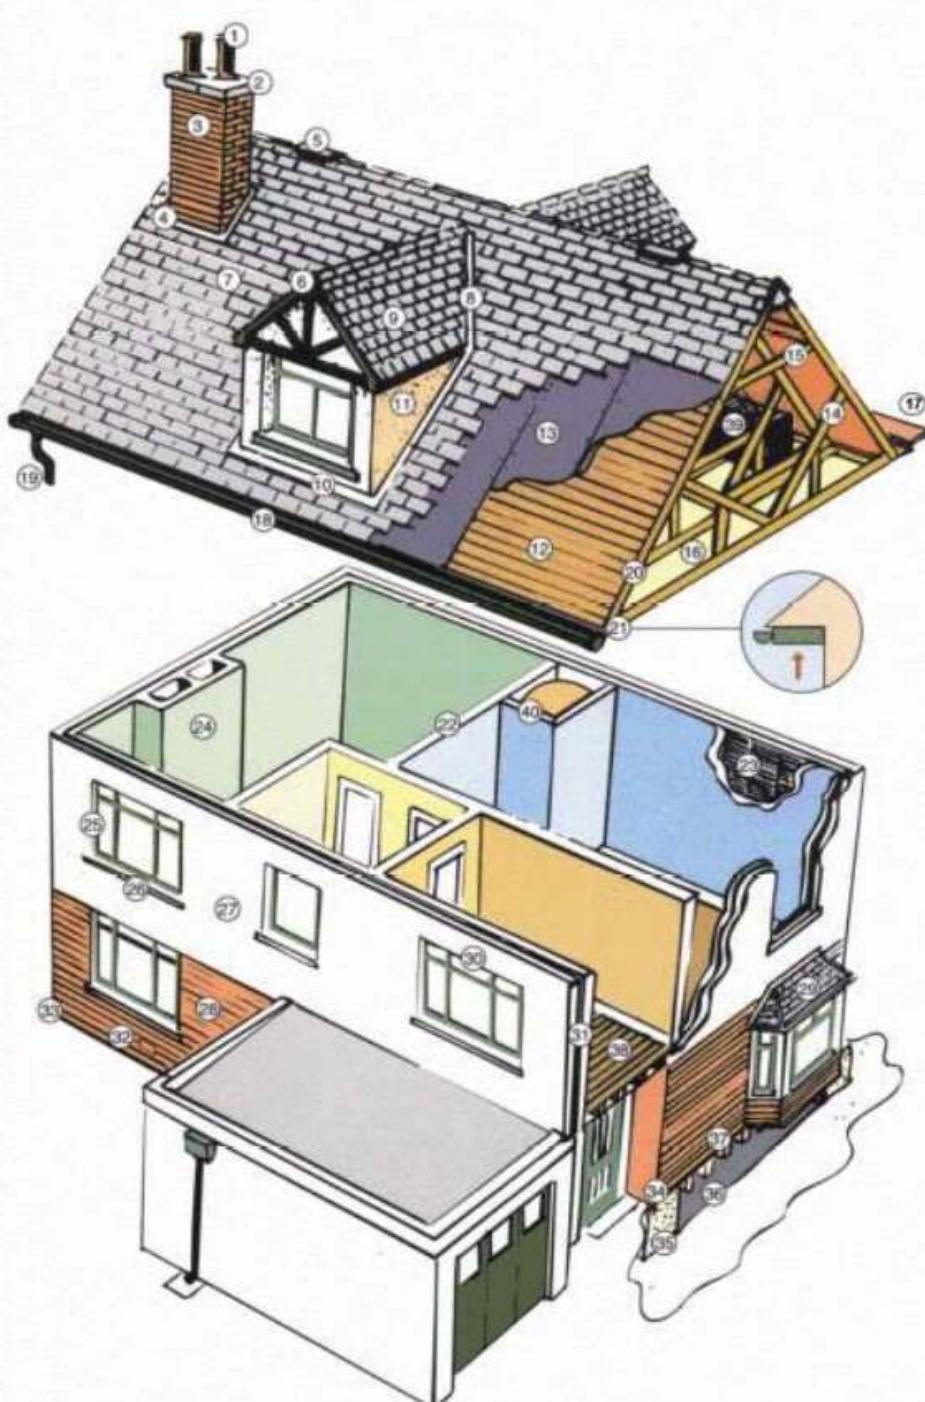
## Sectional Diagram showing elements of a typical house

- 1 Chimney pots
- 2 Coping stone
- 3 Chimney head
- 4 Flashing
- 5 Ridge ventilation
- 6 Ridge board
- 7 Slates / tiles
- 8 Valley guttering
- 9 Dormer projection
- 10 Dormer flashing
- 11 Dormer cheeks
- 12 Sarking
- 13 Roof felt
- 14 Trusses
- 15 Collar
- 16 Insulation
- 17 Parapet gutter
- 18 Eaves guttering
- 19 Rainwater downpipe
- 20 Verge boards / skewers
- 21 Soffit boards
- 22 Partition wall
- 23 Lath / plaster
- 24 Chimney breast
- 25 Window pointing
- 26 Window sills
- 27 Rendering
- 28 Brickwork / pointing
- 29 Bay window projection
- 30 Lintels
- 31 Cavity walls / wall ties
- 32 Subfloor ventilator
- 33 Damp proof course
- 34 Base course
- 35 Foundations
- 36 Solum
- 37 Floor joists
- 38 Floorboards
- 39 Water tank
- 40 Hot water tank

Reference may be made in this report to some or all of the above component parts of the property. This diagram may assist you in locating and understanding these items.

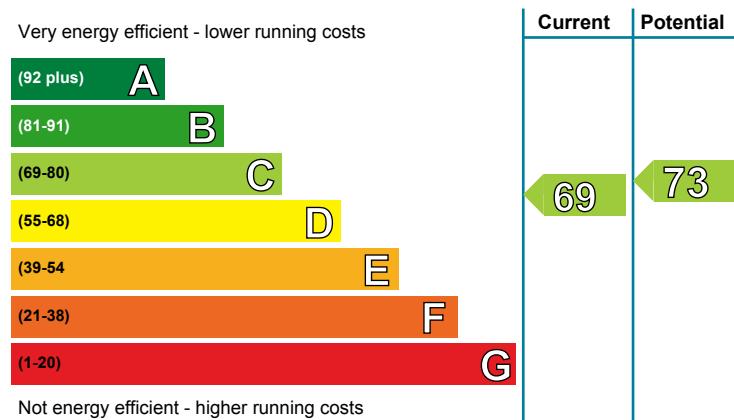
## Energy Efficiency Rating

This graph shows the current efficiency of your home, taking into account both energy efficiency and fuel costs. The higher this rating, the lower your fuel bills are likely to be.

Your current rating is **band C (69)**. The average rating for EPCs in Scotland is **band D (61)**.

The potential rating shows the effect of undertaking all of the improvement measures listed within your recommendations report.

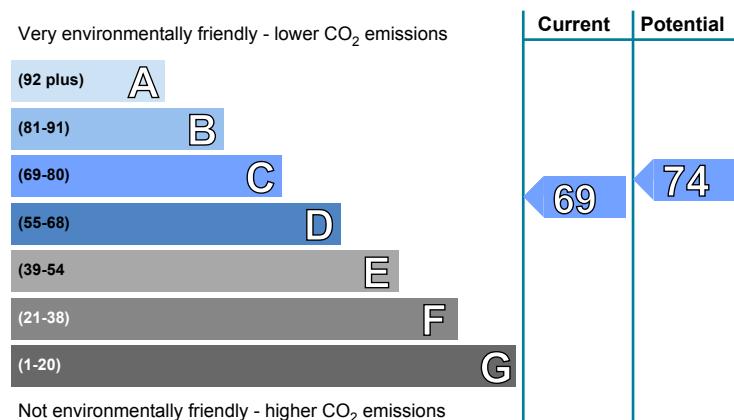
## Environmental Impact (CO<sub>2</sub>) Rating

This graph shows the effect of your home on the environment in terms of carbon dioxide (CO<sub>2</sub>) emissions. The higher the rating, the less impact it has on the environment.
