HOME REPORT

18 HENDRYS WYND, KIRKCALDY, KY1 1QD

Dwelling type:	End-terrace house	Reference number:	0277-1924-5200-8414-2204
Date of assessment:	03 October 2024	Type of assessment:	RdSAP, existing dwelling
Date of certificate:	04 October 2024	Approved Organisation:	Elmhurst
Total floor area:	85 m ²	Main heating and fuel:	Boiler and radiators, mains gas
Primary Energy Indicator:	238 kWh/m ² /year

Single Survey

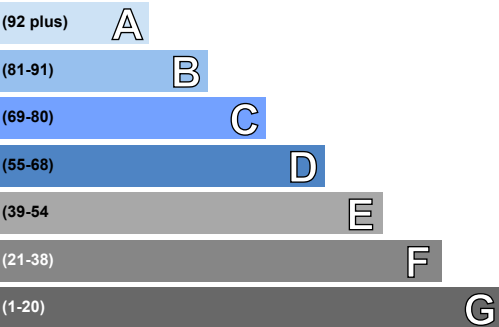
Environmental Impact (CO₂) Rating

This graph shows the effect of your home on the environment in terms of carbon dioxide (CO₂) emissions. The higher the rating, the less impact it has on the environment.

Your current rating is **band D (67)**. The average rating for EPCs in Scotland is **band D (59)**.

The potential rating shows the effect of undertaking all of the improvement measures listed within your recommendations report.
