# Home Report

# Single Survey

| <b>Property address</b> | 18 Macindoe Crescent<br>Kirkcaldy<br>KY1 2JF |

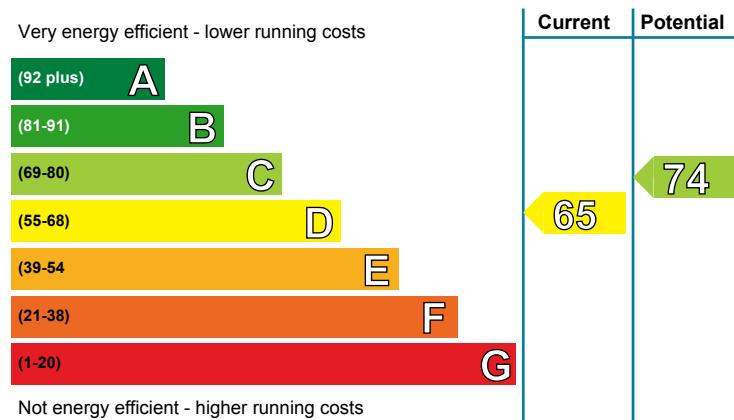
## Energy Efficiency Rating

This graph shows the current efficiency of your home, taking into account both energy efficiency and fuel costs. The higher this rating, the lower your fuel bills are likely to be.

Your current rating is **band D (65)**. The average rating for EPCs in Scotland is **band D (61)**.

The potential rating shows the effect of undertaking all of the improvement measures listed within your recommendations report.

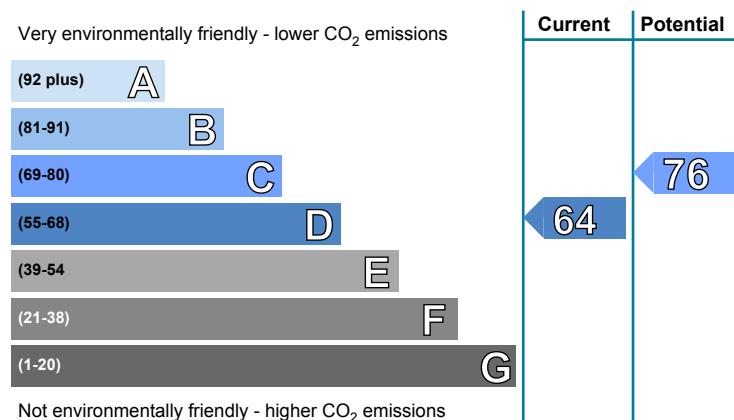
## Environmental Impact (CO<sub>2</sub>) Rating

This graph shows the effect of your home on the environment in terms of carbon dioxide (CO<sub>2</sub>) emissions. The higher the rating, the less impact it has on the environment.
