Home Report

Single Survey

14 Grieve Street,
Kirkcaldy,
KY2 5JS

Ewen Sparks BSc (Hons) MRICS
DM Hall LLP Chartered Surveyors
13 Wemyssfield
Kirkcaldy
KY1 1XN
Tel: 01592 598200
email: kirkcaldyresidential@dmhall.co.uk

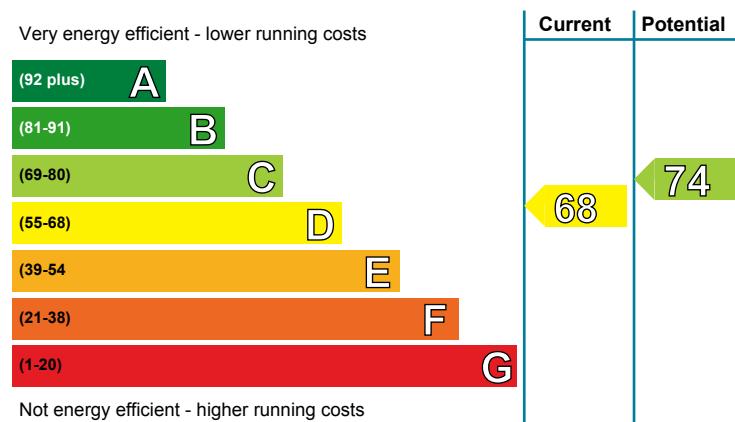
Energy Efficiency Rating

This graph shows the current efficiency of your home, taking into account both energy efficiency and fuel costs. The higher this rating, the lower your fuel bills are likely to be.

Your current rating is **band D (68)**. The average rating for EPCs in Scotland is **band D (61)**.

The potential rating shows the effect of undertaking all of the improvement measures listed within your recommendations report.

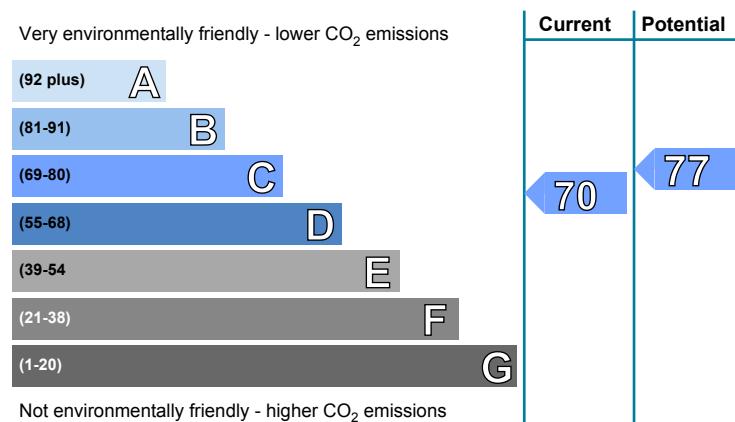
Environmental Impact (CO₂) Rating

This graph shows the effect of your home on the environment in terms of carbon dioxide (CO₂) emissions. The higher the rating, the less impact it has on the environment.
