Home Report

Single Survey

14 Hopetoun Place,
Kirkcaldy,
Fife,
KY2 6TY

29th January 2026

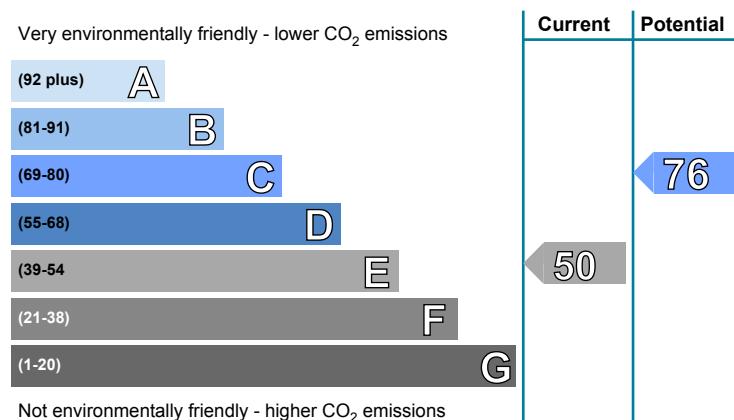
Environmental Impact (CO₂) Rating

This graph shows the effect of your home on the environment in terms of carbon dioxide (CO₂) emissions. The higher the rating, the less impact it has on the environment.
