4 Brae Head Lodge, Victoria Road, Kirkcaldy, Fife, KY1 2SA

Home Report

# Single Survey

Property Address	4 Brae Head Lodge, Victoria Road, Kirkcaldy, Fife, KY1 2SA
Reference	1217807
Customer Name	Lynne Thomson
Date of Inspection	3rd September 2025
Surveyor's name, qualifications and office	Tracy Hutchison  DM Hall LLP Chartered Surveyors 13 Wemyssfield Kirkcaldy KY1 1XN  Tel: 01592 598200  email: kirkcaldyresidential@dmhall.co.uk
Prepared By	DM Hall LLP

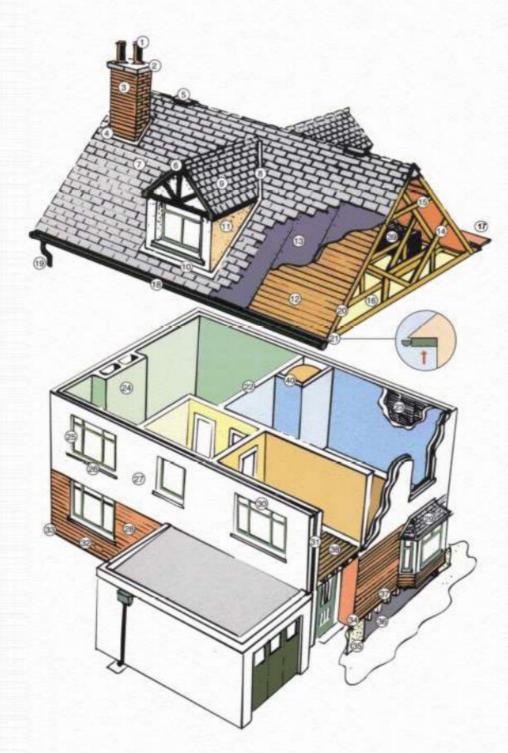
# Sectional Diagram showing elements of a typical house

Reference may be made in this report to some or all of the above component parts of the property. This diagram may assist you in locating and understanding these items.

- 1) Chimney pots
- 2 Coping stone
- 3) Chimney head
- (4) Flashing
- 5 Ridge ventilation
- 6) Ridge board
- (7) Slates / tiles
- (8) Valley guttering
- 9 Dormer projection
- 10 Dormer flashing
- 11) Dormer cheeks
- (12) Sarking
- (13) Roof felt
- (14) Trusses
- (15) Collar
- (16) Insulation
- (17) Parapet gutter
- rarapet gutter
- 18) Eaves guttering
- (19) Rainwater downpipe
- 20) Verge boards /skews
- 21) Soffit boards
- (22) Partition wall
- (23) Lath / plaster
- (24) Chimney breast
- (25) Window pointing
- (26) Window sills
- (27) Rendering
- (28) Brickwork / pointing
- (29) Bay window projection
- (30) Lintels
- (31) Cavity walls / wall ties
- (32) Subfloor ventilator
- (33) Damp proof course
- 34) Base course
- 35 Foundations
- 36) Solum
- (37) Floor joists
- 38) Floorboards
- 39 Water tank
- 40 Hot water tank
