121 Dunearn Drive,  
Kirkcaldy,  
KY2 6LB

# Home Report

# Single Survey

<b>Property Address</b>	121 Dunearn Drive, Kirkcaldy, KY2 6LB
<b>Reference</b>	1487434
<b>Customer Name</b>	Lorraine Doig
<b>Date of Inspection</b>	17th March 2026
<b>Surveyor's name, qualifications and office</b>	Ewen Sparks BSc (Hons) MRICS DM Hall LLP Chartered Surveyors 13 Wemyssfield Kirkcaldy KY1 1XN  Tel: 01592 598200  email: kirkcaldyresidential@dmhall.co.uk
<b>Prepared By</b>	DM Hall LLP

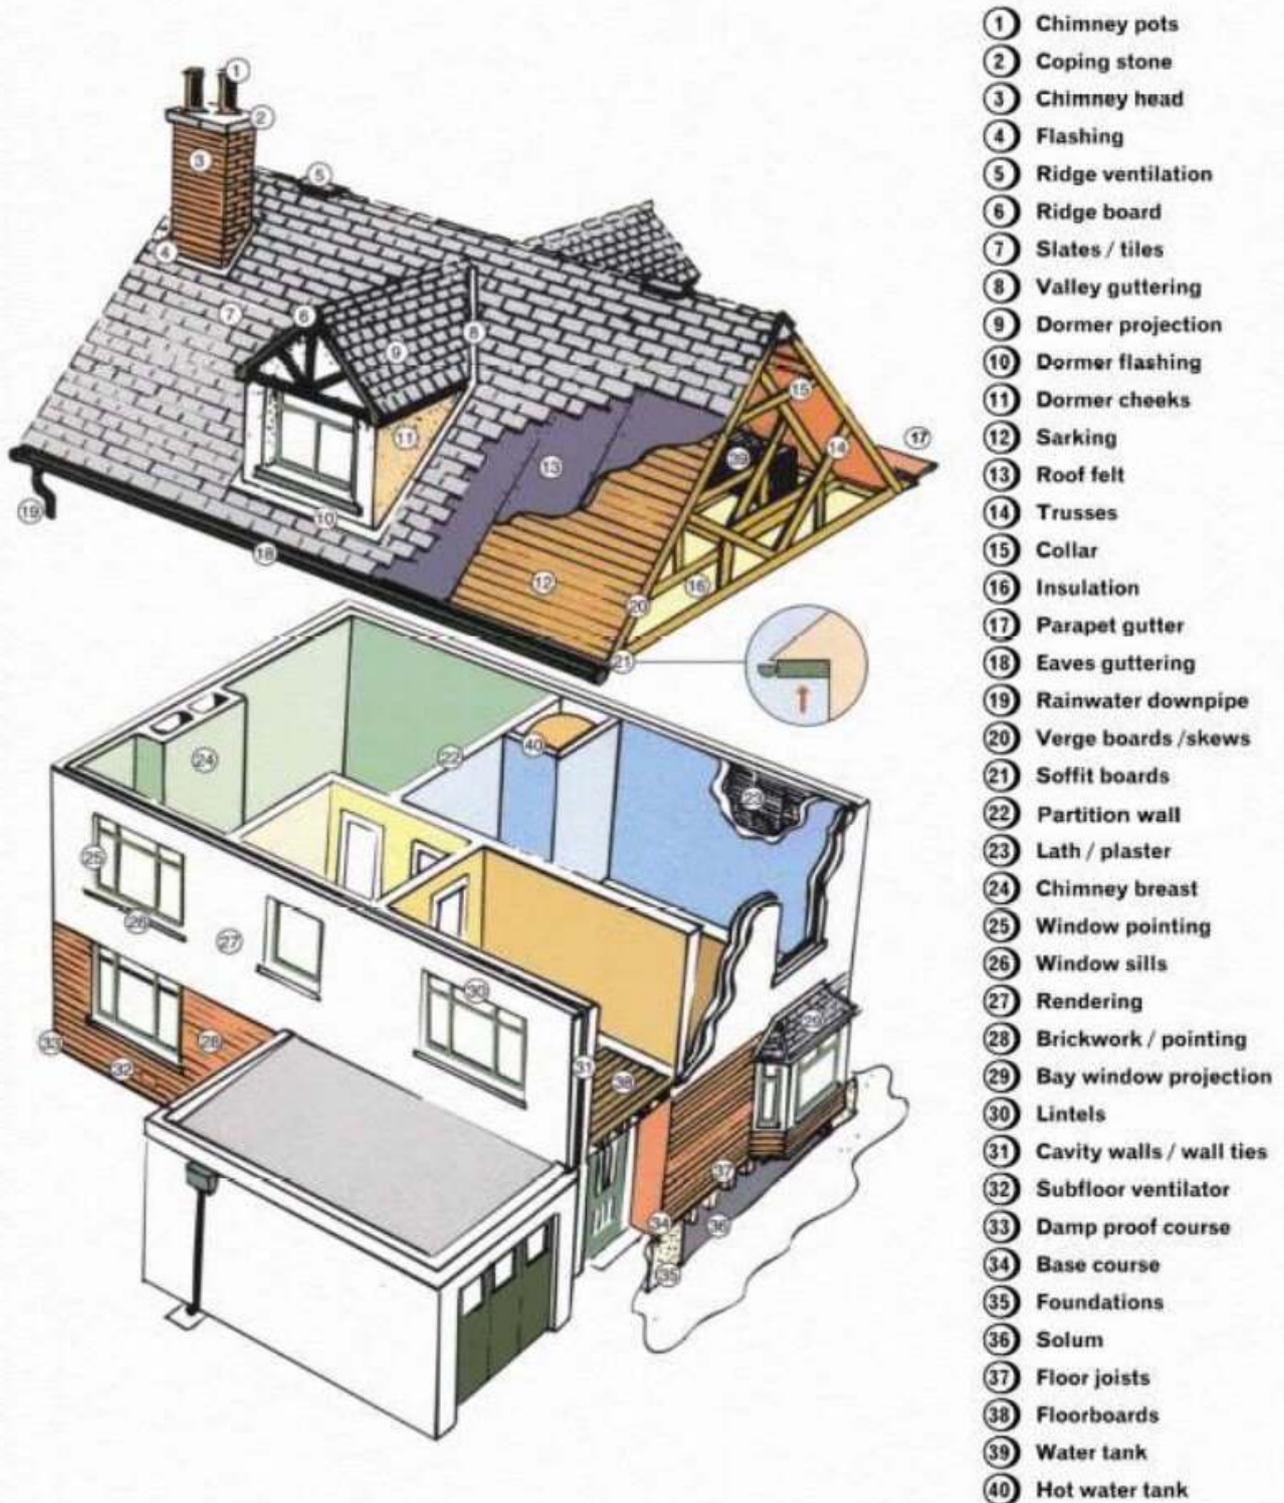
## Sectional Diagram showing elements of a typical house

- ① Chimney pots
- ② Coping stone
- ③ Chimney head
- ④ Flashing
- ⑤ Ridge ventilation
- ⑥ Ridge board
- ⑦ Slates / tiles
- ⑧ Valley guttering
- ⑨ Dormer projection
- ⑩ Dormer flashing
- ⑪ Dormer cheeks
- ⑫ Sarking
- ⑬ Roof felt
- ⑭ Trusses
- ⑮ Collar
- ⑯ Insulation
- ⑰ Parapet gutter
- ⑱ Eaves guttering
- ⑲ Rainwater downpipe
- ⑳ Verge boards /skews
- ㉑ Soffit boards
- ㉒ Partition wall
- ㉓ Lath / plaster
- ㉔ Chimney breast
- ㉕ Window pointing
- ㉖ Window sills
- ㉗ Rendering
- ㉘ Brickwork / pointing
- ㉙ Bay window projection
- ㉚ Lintels
- ㉛ Cavity walls / wall ties
- ㉜ Subfloor ventilator
- ㉝ Damp proof course
- ㉞ Base course
- ㉟ Foundations
- ㊱ Solum
- ㊲ Floor joists
- ㊳ Floorboards
- ㊴ Water tank
- ㊵ Hot water tank

Reference may be made in this report to some or all of the above component parts of the property. This diagram may assist you in locating and understanding these items.

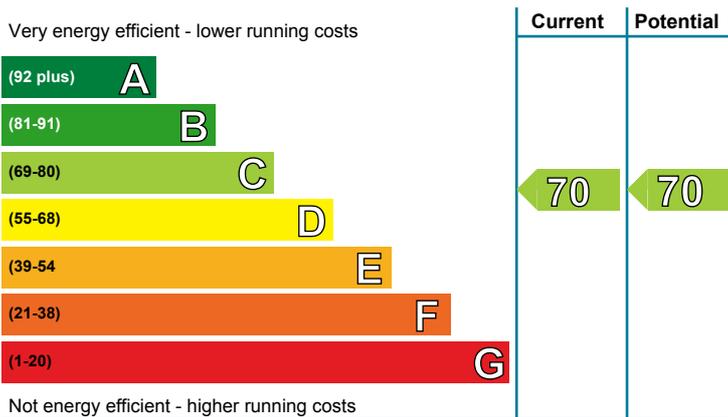
## Energy Efficiency Rating

This graph shows the current efficiency of your home, taking into account both energy efficiency and fuel costs. The higher this rating, the lower your fuel bills are likely to be.

Your current rating is **band C (70)**. The average rating for EPCs in Scotland is **band D (61)**.

The potential rating shows the effect of undertaking all of the improvement measures listed within your recommendations report.

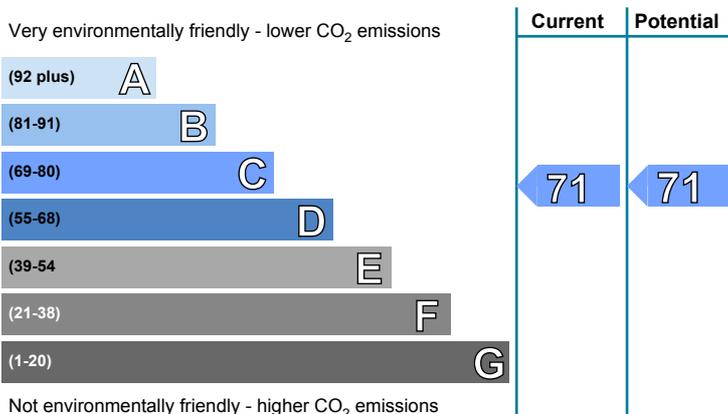
## Environmental Impact (CO<sub>2</sub>) Rating

This graph shows the effect of your home on the environment in terms of carbon dioxide (CO<sub>2</sub>) emissions. The higher the rating, the less impact it has on the environment.
