HOME REPORT

14 BIRRELL CLOSE, KIRKCALDY, KY1 2NT

Single Survey

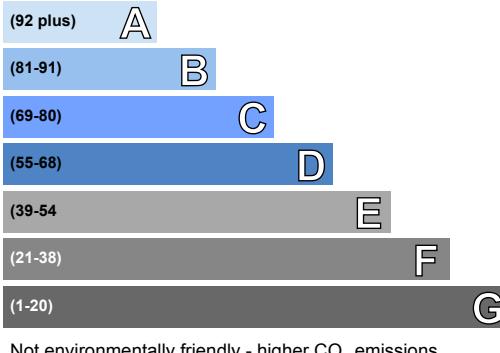
Very environmentally friendly - lower CO₂ emissions

Current Potential

84 84
