# HOME REPORT

6 EAST FERGUS PLACE  
KIRKCALDY  
KY1 1XT

DM HALL  
CHARTERED SURVEYORS

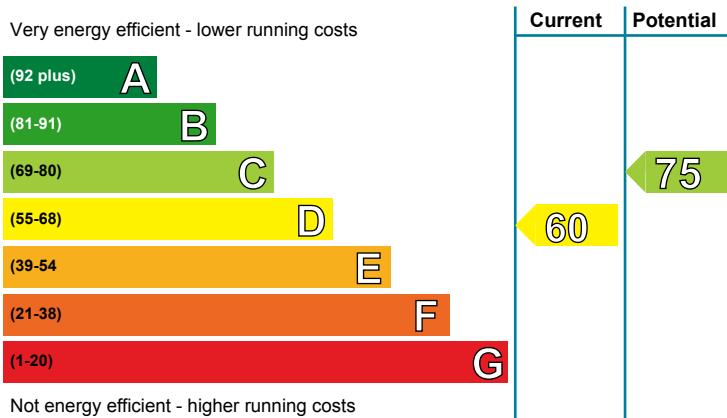
## Energy Efficiency Rating

This graph shows the current efficiency of your home, taking into account both energy efficiency and fuel costs. The higher this rating, the lower your fuel bills are likely to be.

Your current rating is **band D (60)**. The average rating for EPCs in Scotland is **band D (61)**.

The potential rating shows the effect of undertaking all of the improvement measures listed within your recommendations report.

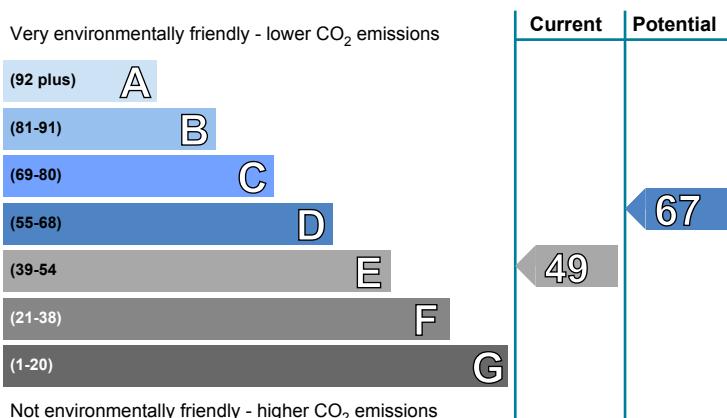
## Environmental Impact (CO<sub>2</sub>) Rating

This graph shows the effect of your home on the environment in terms of carbon dioxide (CO<sub>2</sub>) emissions. The higher the rating, the less impact it has on the environment.

Your current rating is **band E (49)**. The average rating for EPCs in Scotland is **band D (59)**.

The potential rating shows the effect of undertaking all of the improvement measures listed within your recommendations report.
