YOUR ONE SURVEY  
**HOME REPORT**

32 Longbraes Gardens  
Kirkcaldy  
KY2 5YJ

# SINGLE SURVEY

# Single Survey

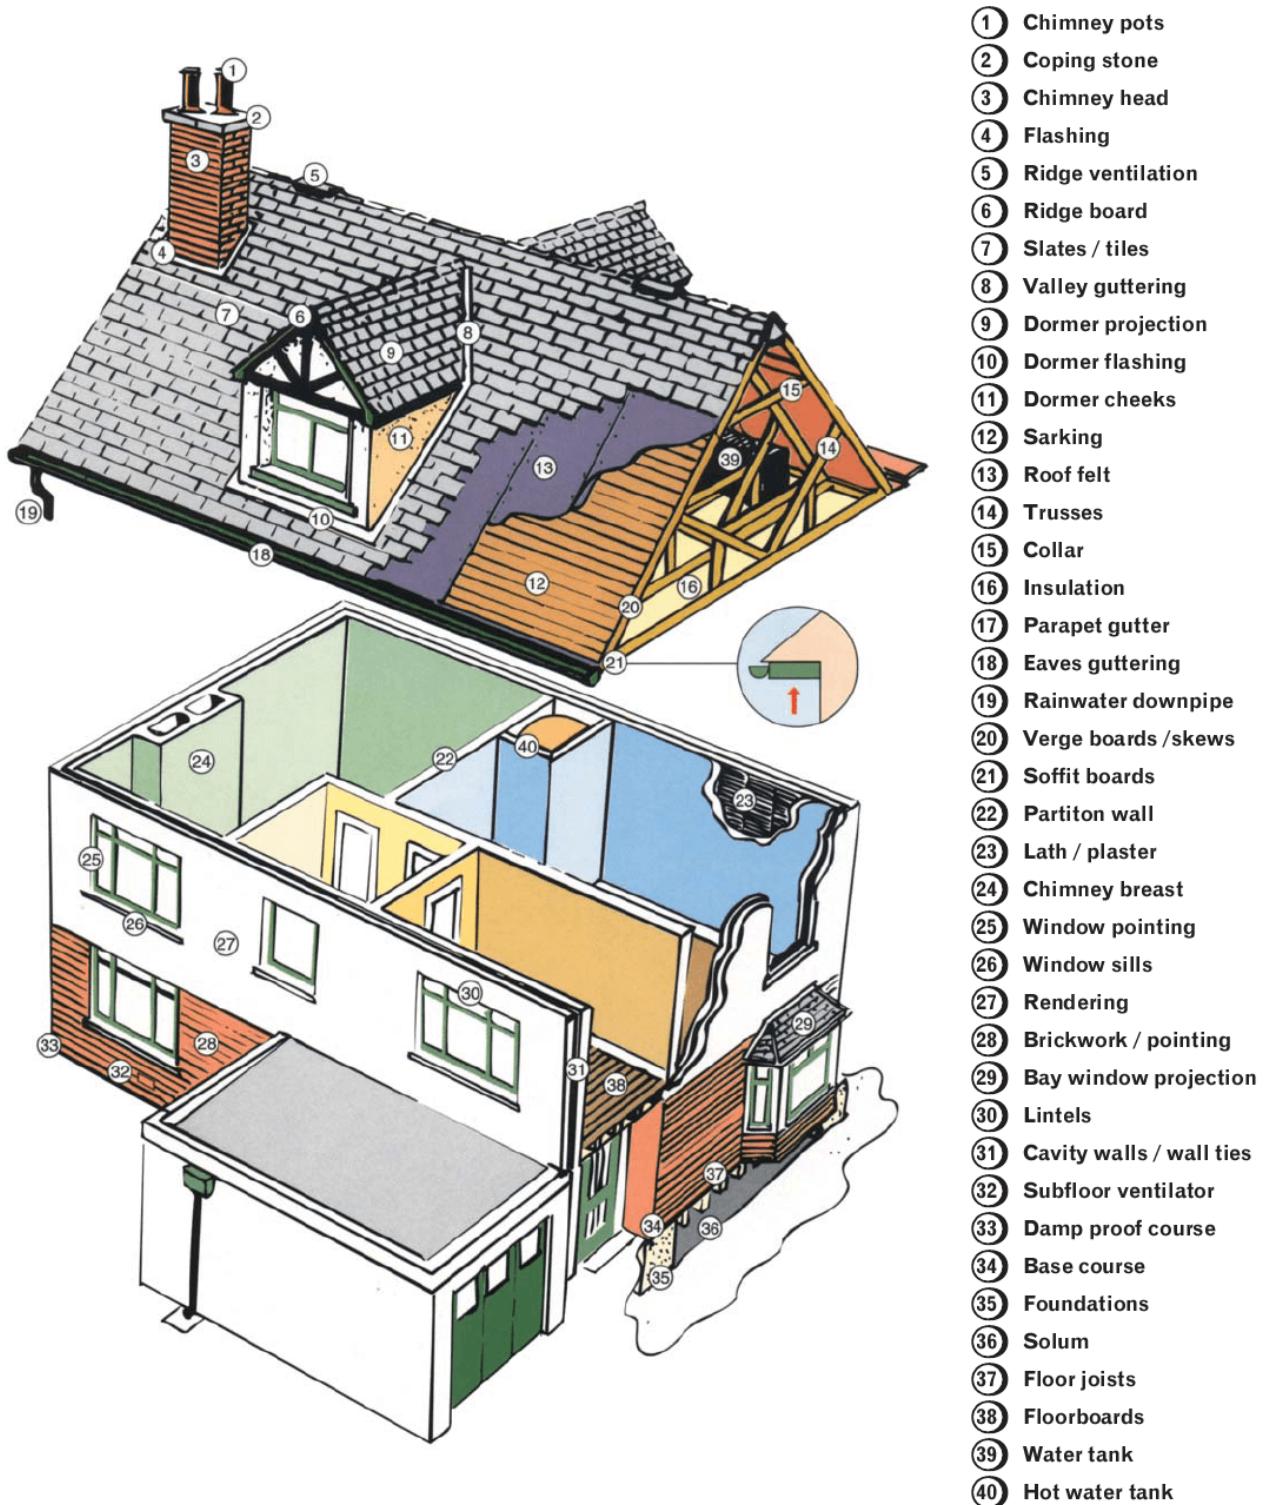
## Sectional Diagram showing elements of a typical house

Reference may be made in this report to some or all of the above component parts of the property. This diagram may assist you in locating and understanding these items.

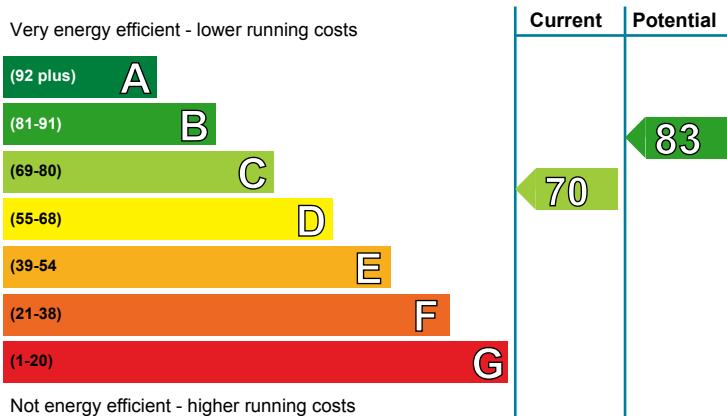
### Energy Efficiency Rating

This graph shows the current efficiency of your home, taking into account both energy efficiency and fuel costs. The higher this rating, the lower your fuel bills are likely to be.

Your current rating is **band C (70)**. The average rating for EPCs in Scotland is **band D (61)**.

The potential rating shows the effect of undertaking all of the improvement measures listed within your recommendations report.

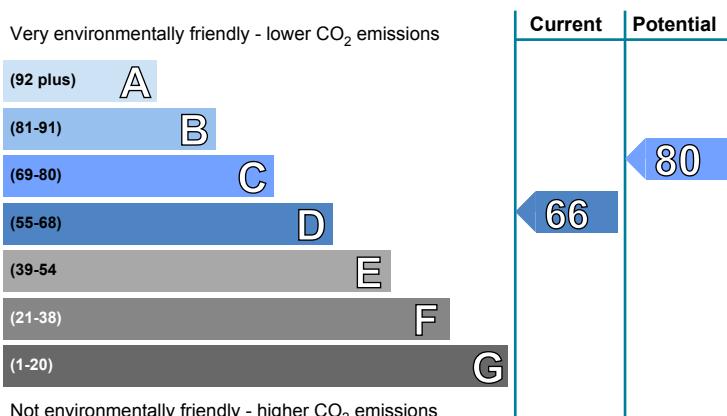
### Environmental Impact (CO<sub>2</sub>) Rating

This graph shows the effect of your home on the environment in terms of carbon dioxide (CO<sub>2</sub>) emissions. The higher the rating, the less impact it has on the environment.
