# HOME REPORT

# Energy Performance Certificate (EPC)

32 FORTH HOUSE, ABBOTSHALL ROAD, KIRKCALDY, KY1 1AN

# Single Survey

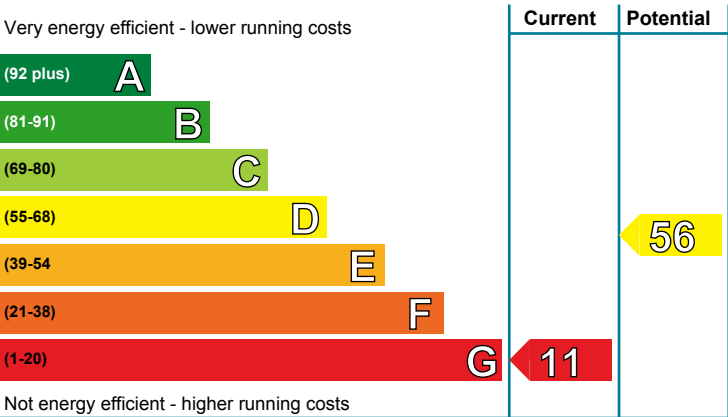
## Energy Efficiency Rating

This graph shows the current efficiency of your home, taking into account both energy efficiency and fuel costs. The higher this rating, the lower your fuel bills are likely to be.

Your current rating is **band G (11)**. The average rating for EPCs in Scotland is **band D (61)**.

The potential rating shows the effect of undertaking all of the improvement measures listed within your recommendations report.

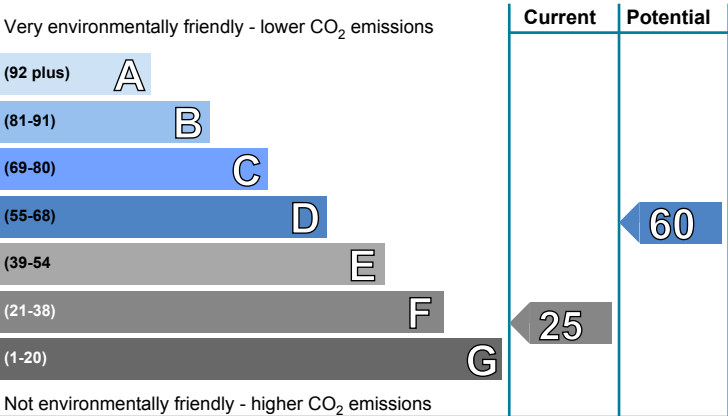
## Environmental Impact (CO<sub>2</sub>) Rating

This graph shows the effect of your home on the environment in terms of carbon dioxide (CO<sub>2</sub>) emissions. The higher the rating, the less impact it has on the environment.

Your current rating is **band F (25)**. The average rating for EPCs in Scotland is **band D (59)**.

The potential rating shows the effect of undertaking all of the improvement measures listed within your recommendations report.
