# Home Report

# Single Survey

<b>Property address</b>	Braeside Cluny Kirkcaldy KY2 6QS
<b>Customer</b>	Andy Loudon
<b>Customer address</b>	Braeside Cluny Kirkcaldy KY2 6QS
<b>Prepared by</b>	Shepherd Chartered Surveyors
<b>Date of inspection</b>	02/08/2024

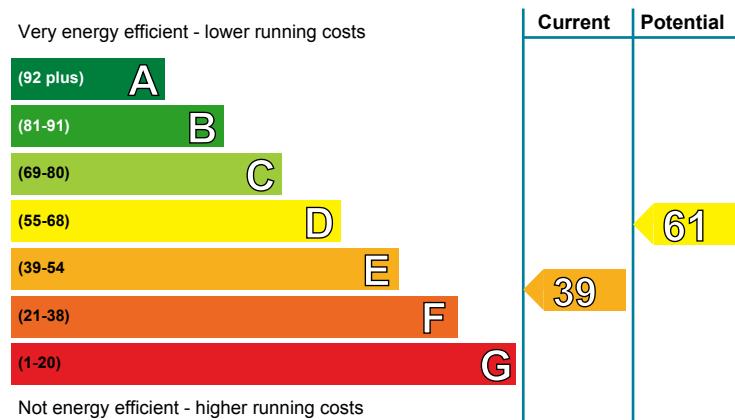
## Energy Efficiency Rating

This graph shows the current efficiency of your home, taking into account both energy efficiency and fuel costs. The higher this rating, the lower your fuel bills are likely to be.

Your current rating is **band E (39)**. The average rating for EPCs in Scotland is **band D (61)**.

The potential rating shows the effect of undertaking all of the improvement measures listed within your recommendations report.

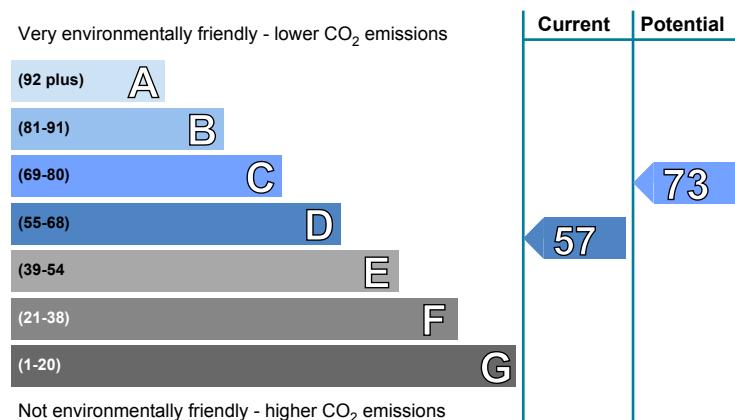
## Environmental Impact (CO<sub>2</sub>) Rating

This graph shows the effect of your home on the environment in terms of carbon dioxide (CO<sub>2</sub>) emissions. The higher the rating, the less impact it has on the environment.
